November 4, 2024

Ms. Brona Simon  
State Historic Preservation Officer  
Massachusetts Historical Commission  
220 Morrissey Boulevard  
Boston, MA 02125  
(via certified mail)

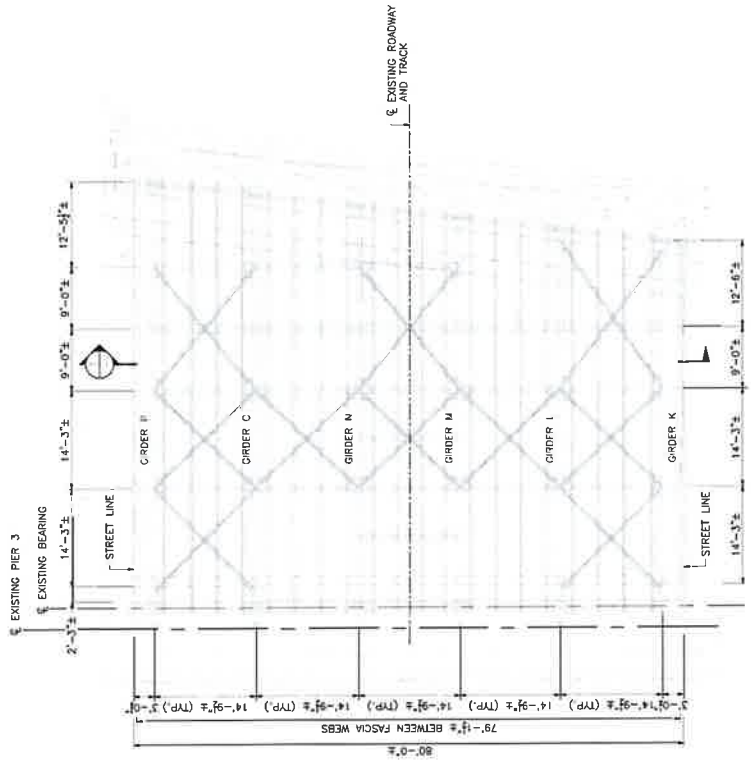
EXISTING FRAMING PLAN - EXISTING SPAN 3  
SCALE: 1/8" = 1'-0"

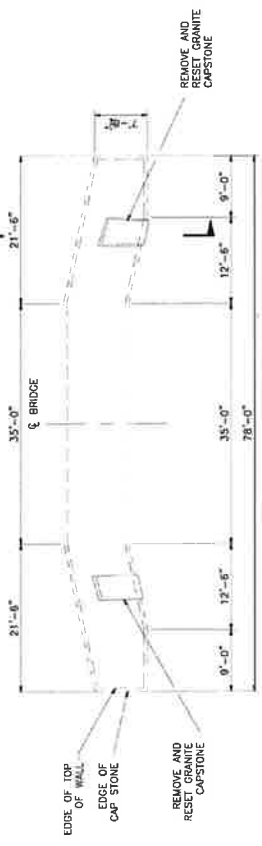
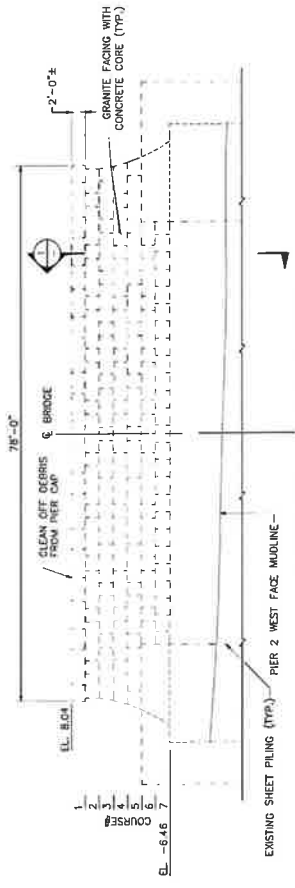
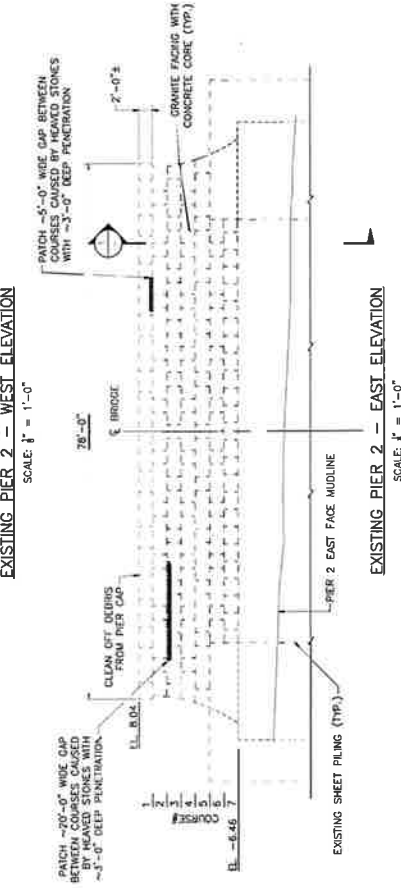
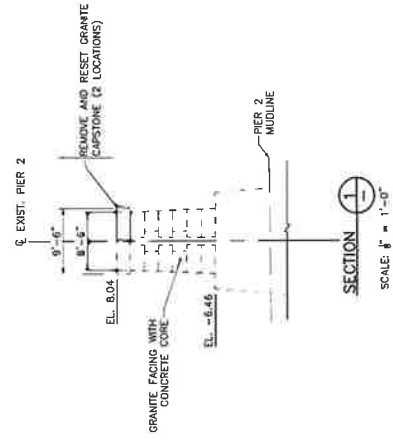
- AFTER ALL STABILIZATION OPERATIONS HAVE BEEN COMPLETED FOR PIER 2, THE PIER CAP SHALL THEN BE CLEANED OF ANY DEBRIS.

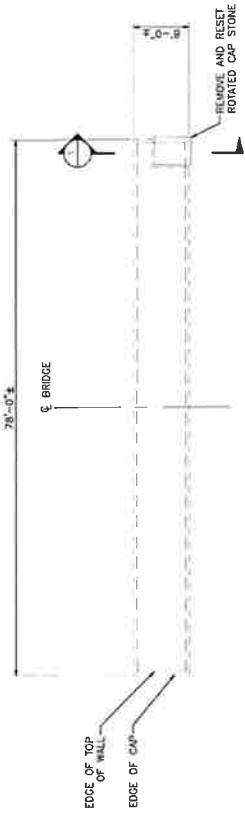
NOTE: PIER FOOTING AND FACE OF WALL NOT SHOWN FOR CLARITY.

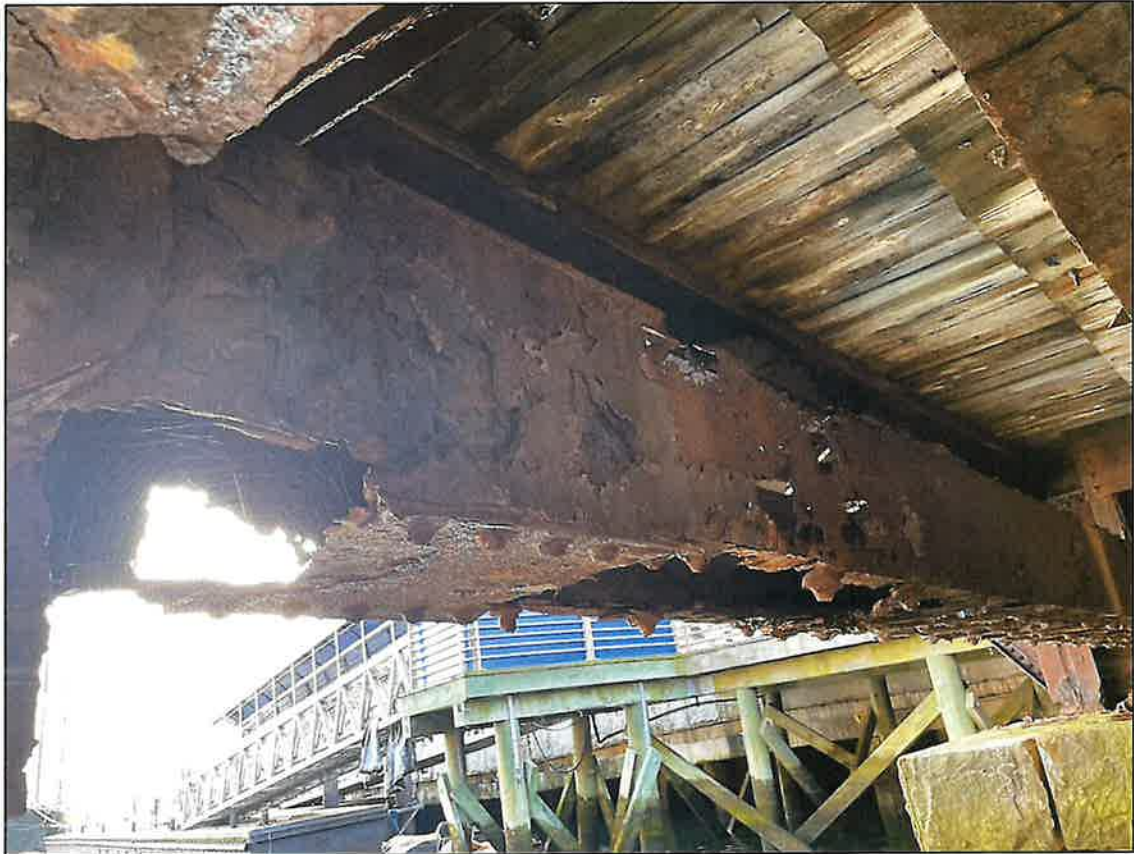
**Photograph 6:** Detail of stringer deterioration at span 2 (easterly fixed, approach span), and missing mortar from pier 3 looking northeast (August 2024).

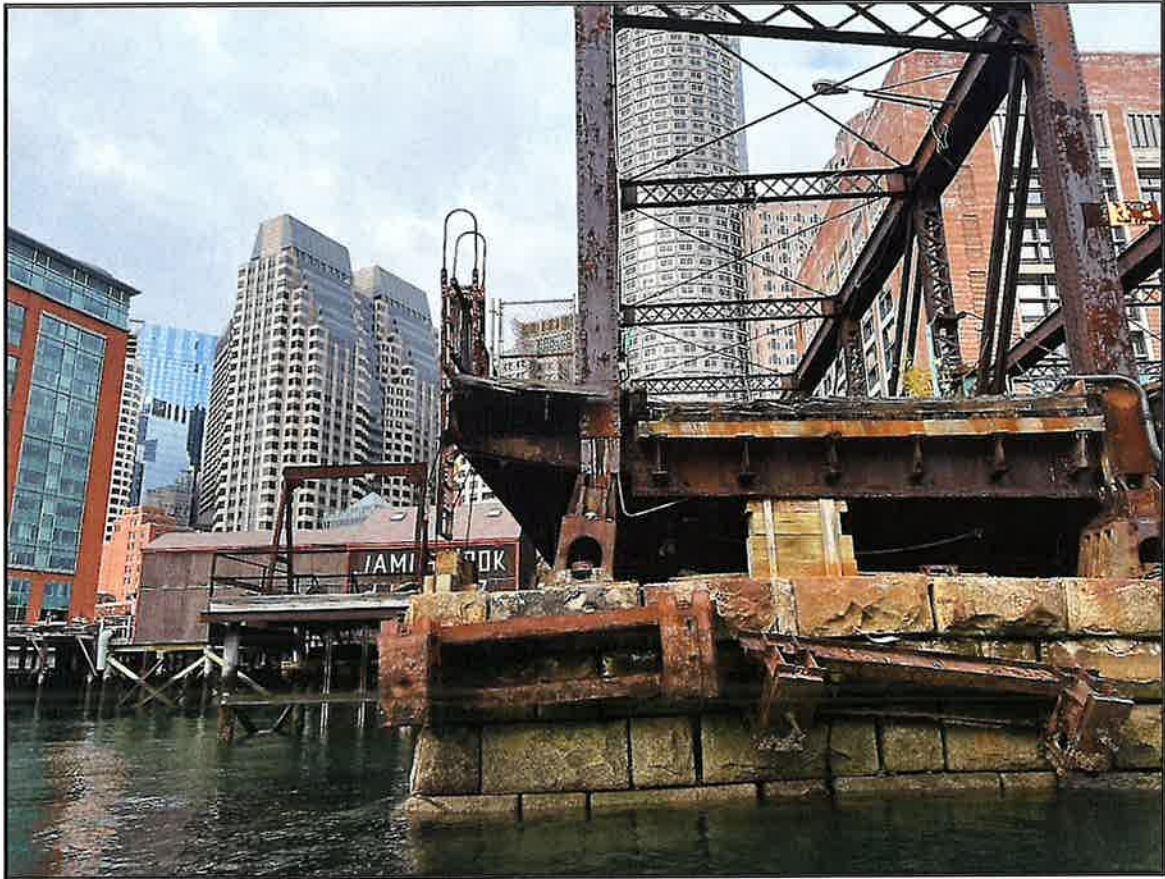
**Photograph 7:** Pier 1, looking west toward span 1 (westerly fixed, approach span). View of failed lagging repair and rotated bearing at pier (November, 2022).

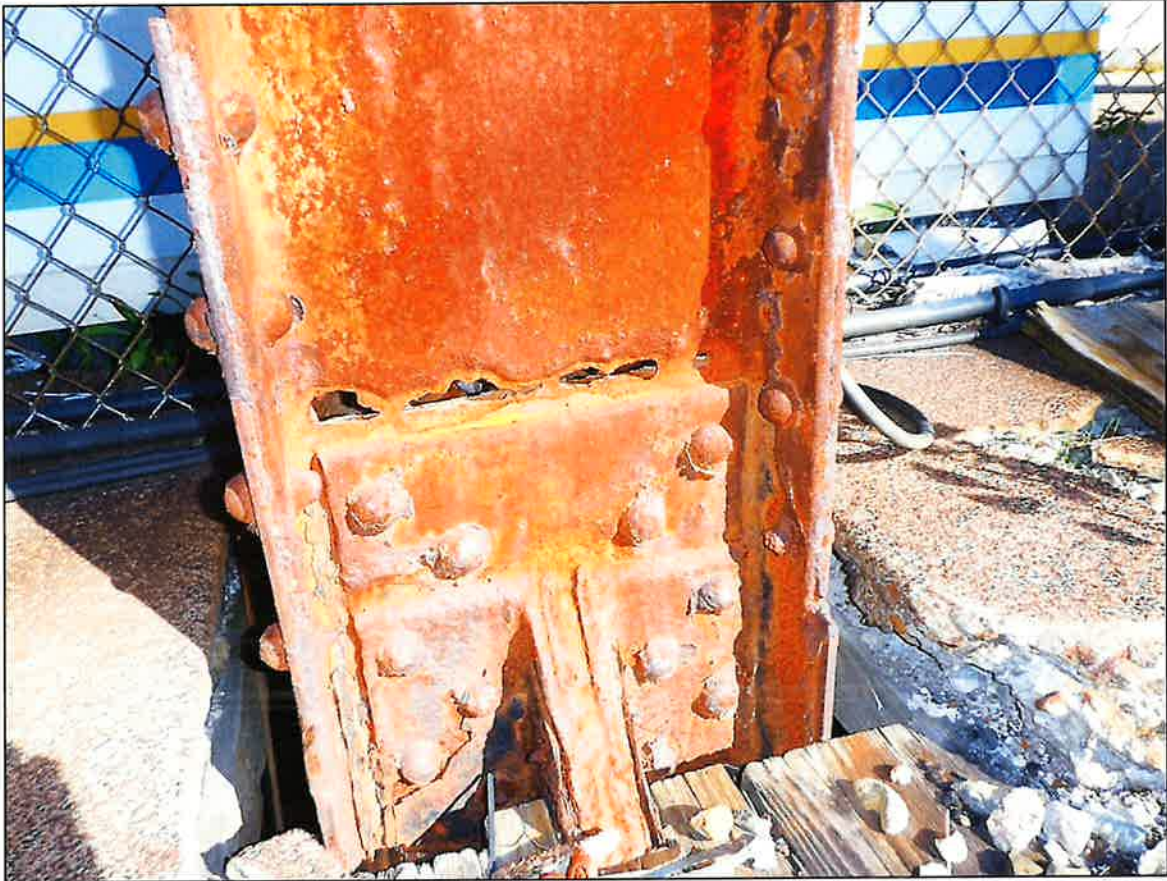
**Photograph 8:** Detail of typical deterioration of web on vertical member at deck level (November, 2022).

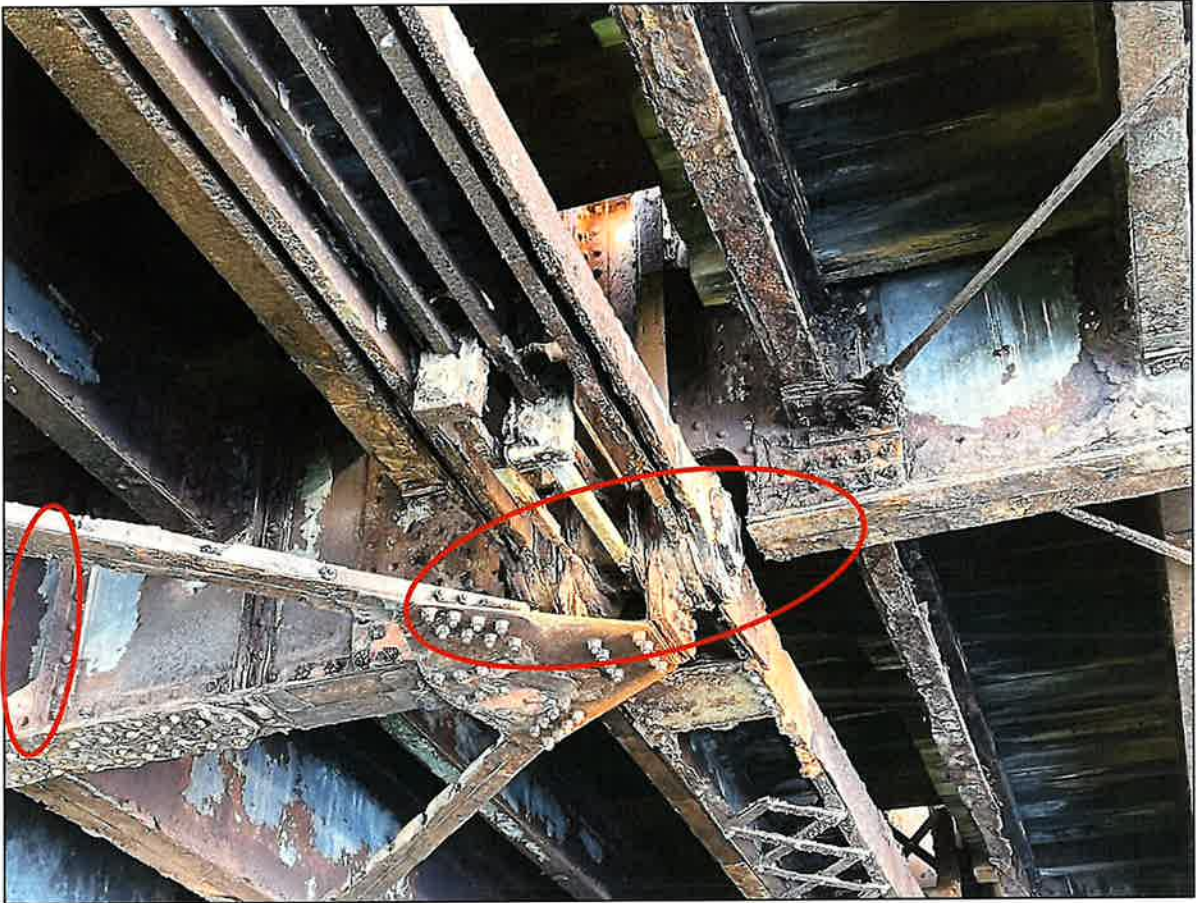
**Photograph 9:** Typical deterioration, section loss, and pack rust at pin connection (November, 2022).

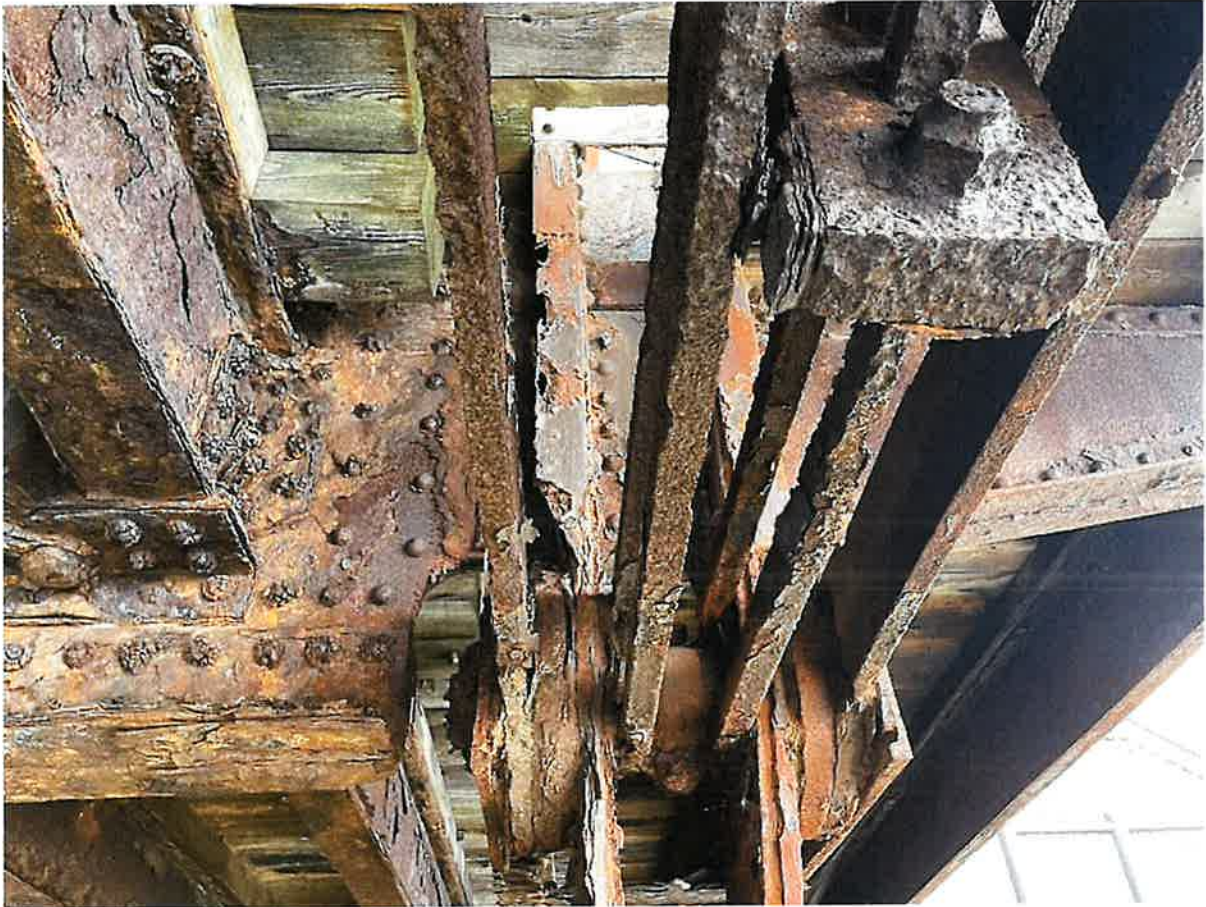
**Photo 1.** Span 1, North Truss, Lower Chord, L2-L3 (Looking West)

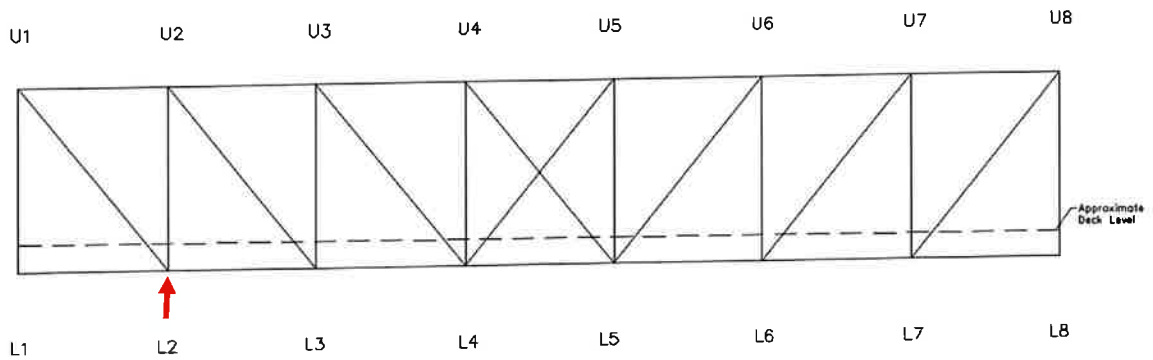
Span 1, North Truss  
South Elevation  
N.T.S

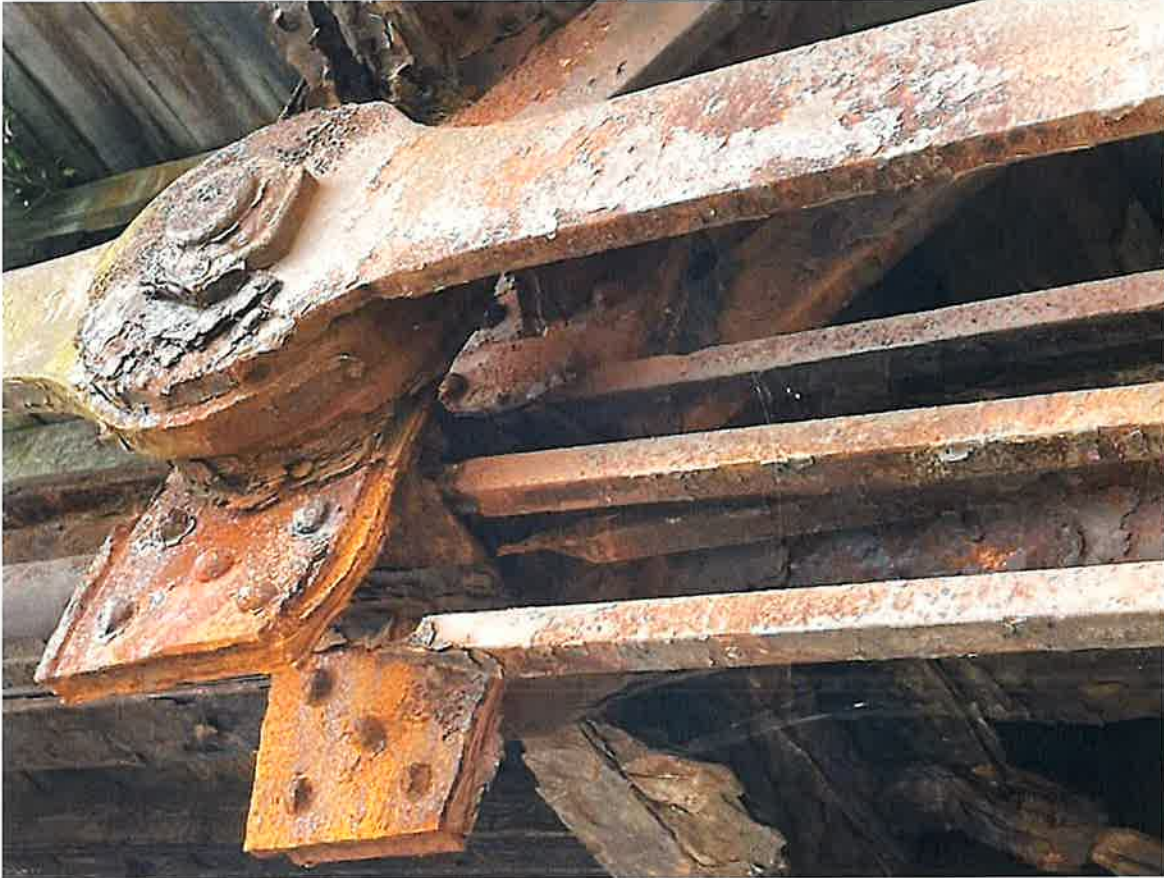
**Photo 2.** Span 1, North Truss, Lower Chord, L2-L3 (Looking East)

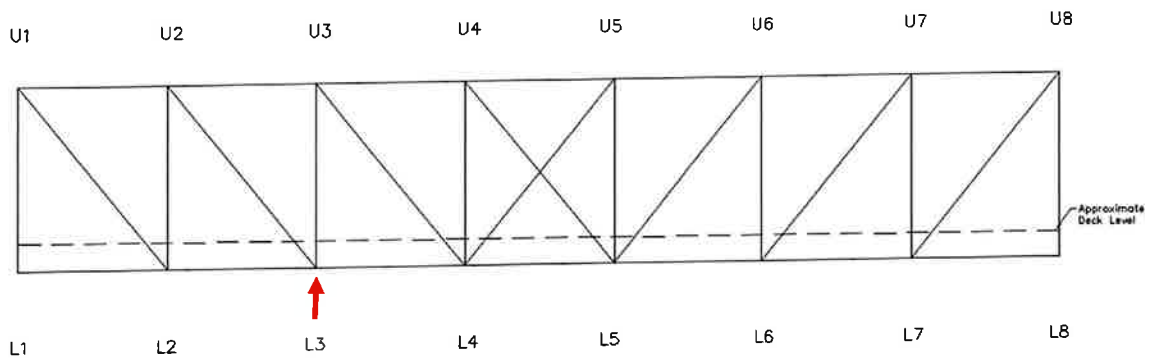
Span 1, North Truss  
South Elevation  
 N.T.S

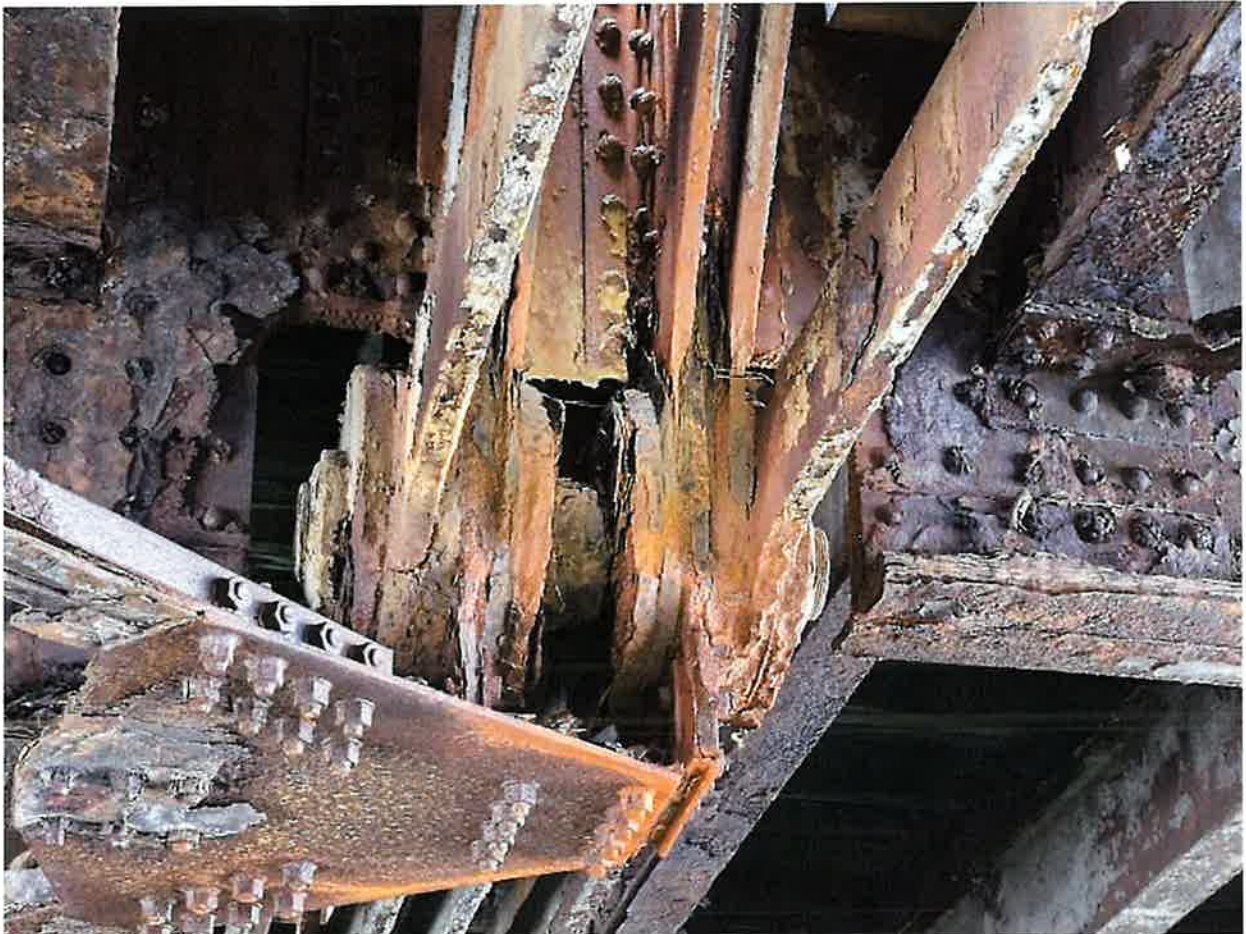
**Photo 3.** Span 1, Center North Truss, Diagonal, L6-U7 (Looking West)

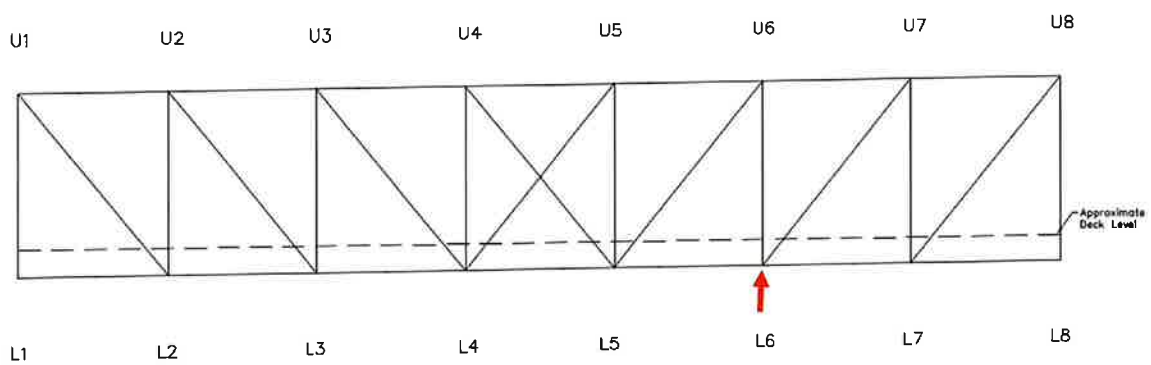
**Span 1, Center North Truss**  
**South Elevation**  
N.T.S

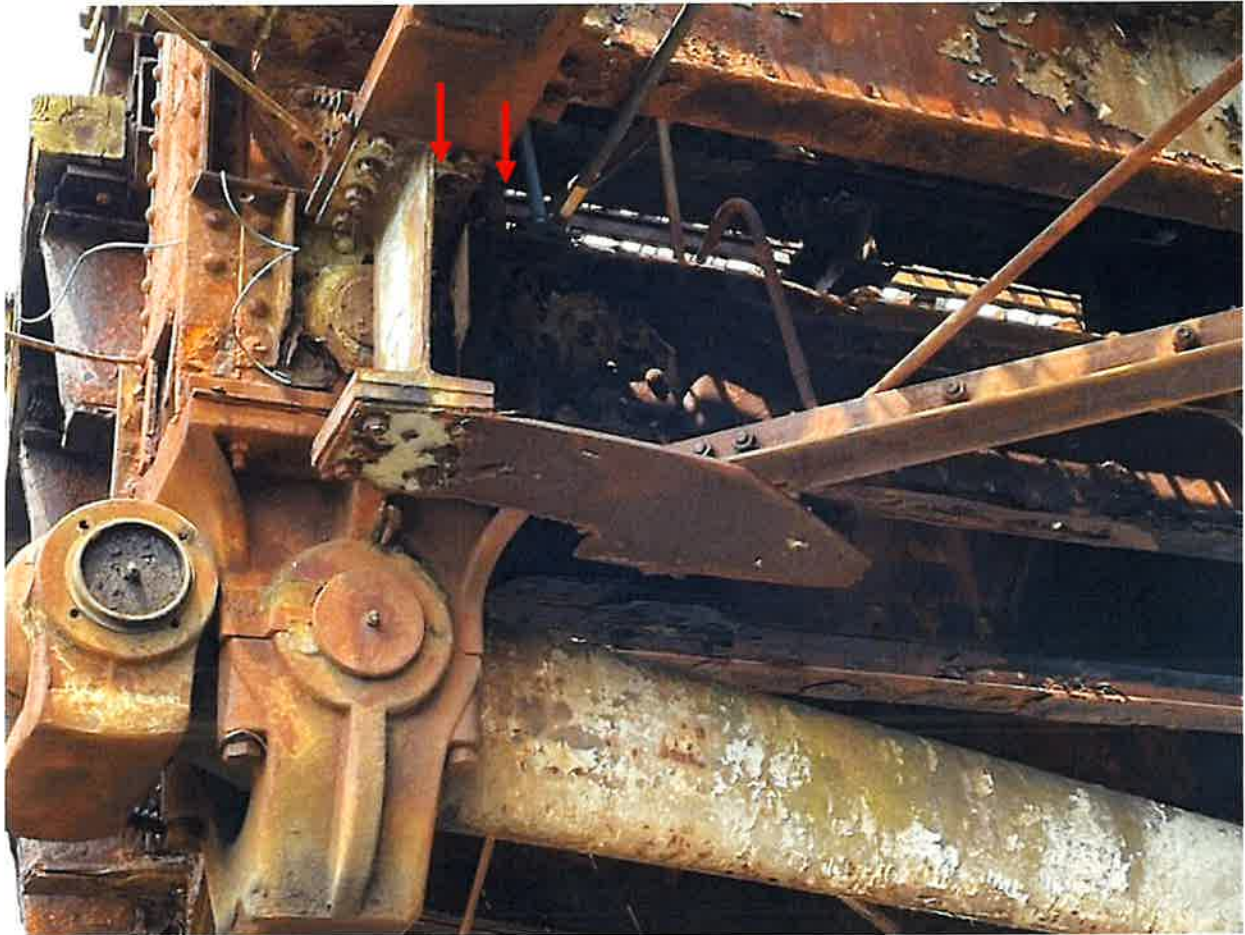
**Photo 4.** Span Swing, Center North Truss, Lower Chord, L9-L10 (Looking True North)  
The south channel web and top flange are buckled. Channel webs have up to 1/4" loss. The top and bottom flanges have rust holes

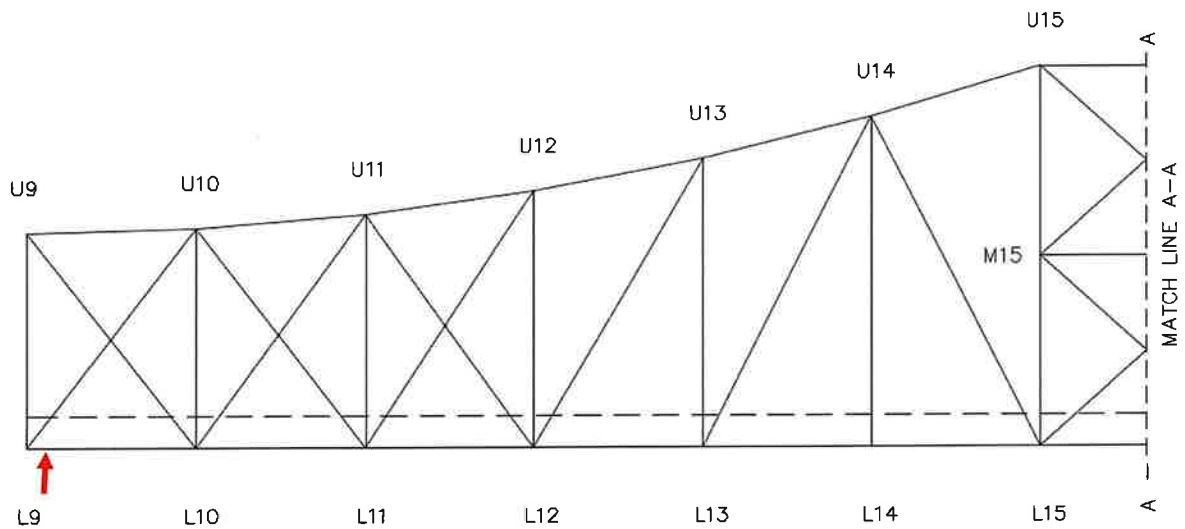
**Swing Span, Center North Truss**  
**South Elevation**  
N.T.S

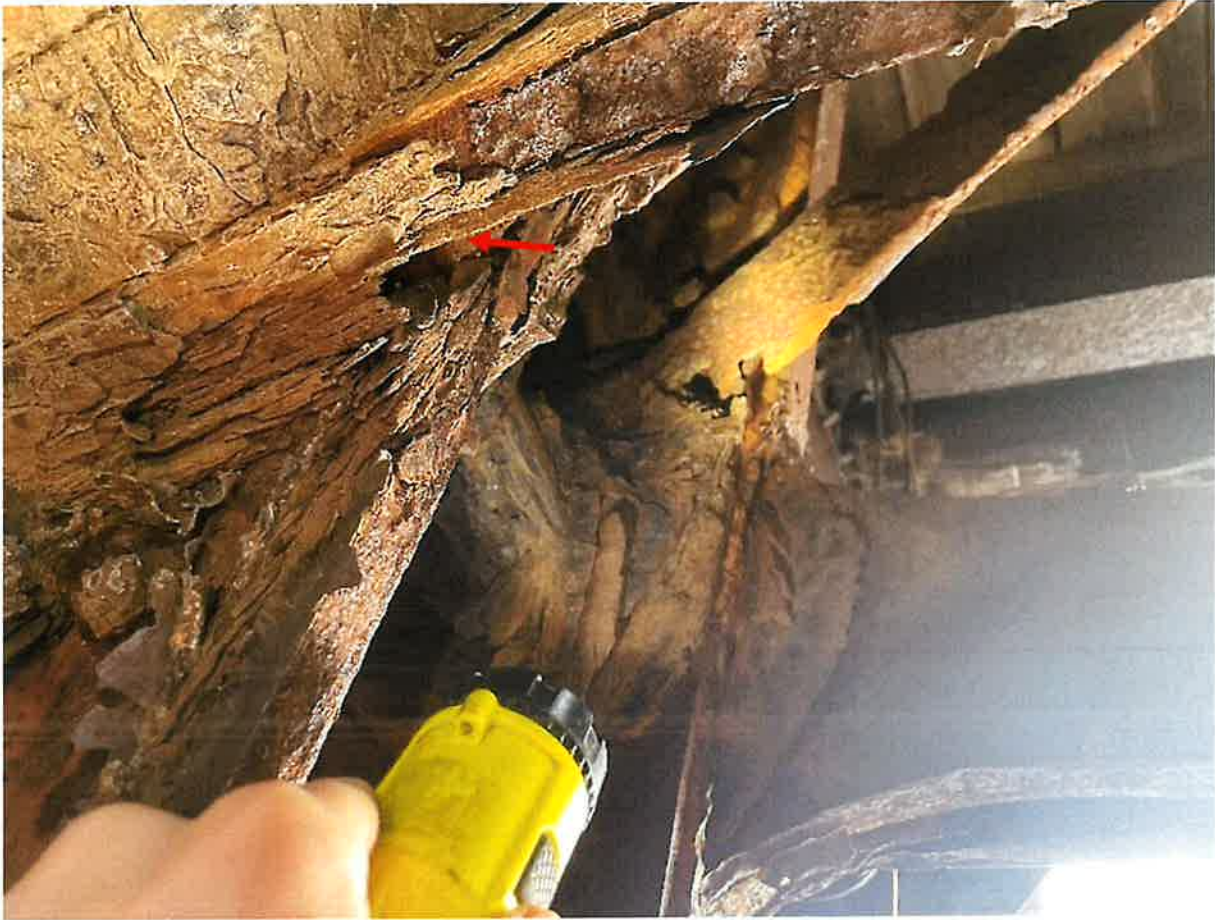
**Photo 5.** Span 2, North Truss, Diagonal, L26-U27 (Looking Northwest)  
The north diagonal bar has a 3" W x 3" H rust hole at the bottom with 1-1/2" for the remaining width. The south diagonal bar has 1/4" average remaining by full width. If the north diagonal bar fails, the south diagonal bar will have torsional forces.

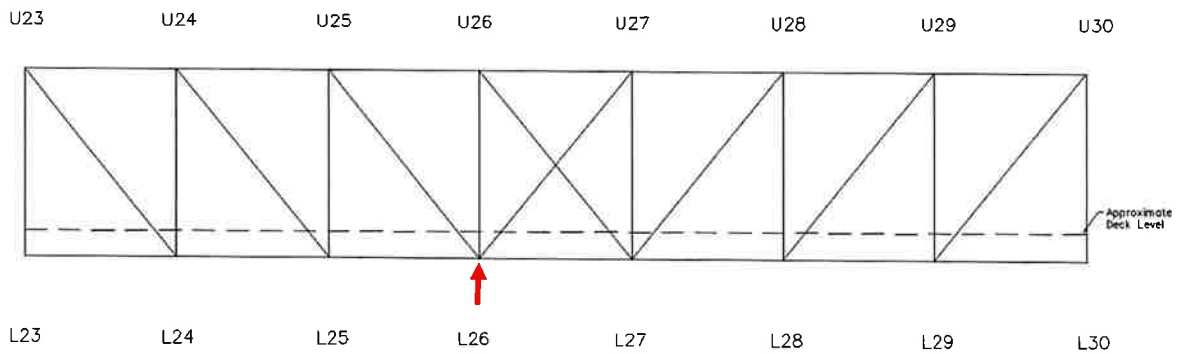
**Span 2, North Truss**  
**South Elevation**  
N.T.S

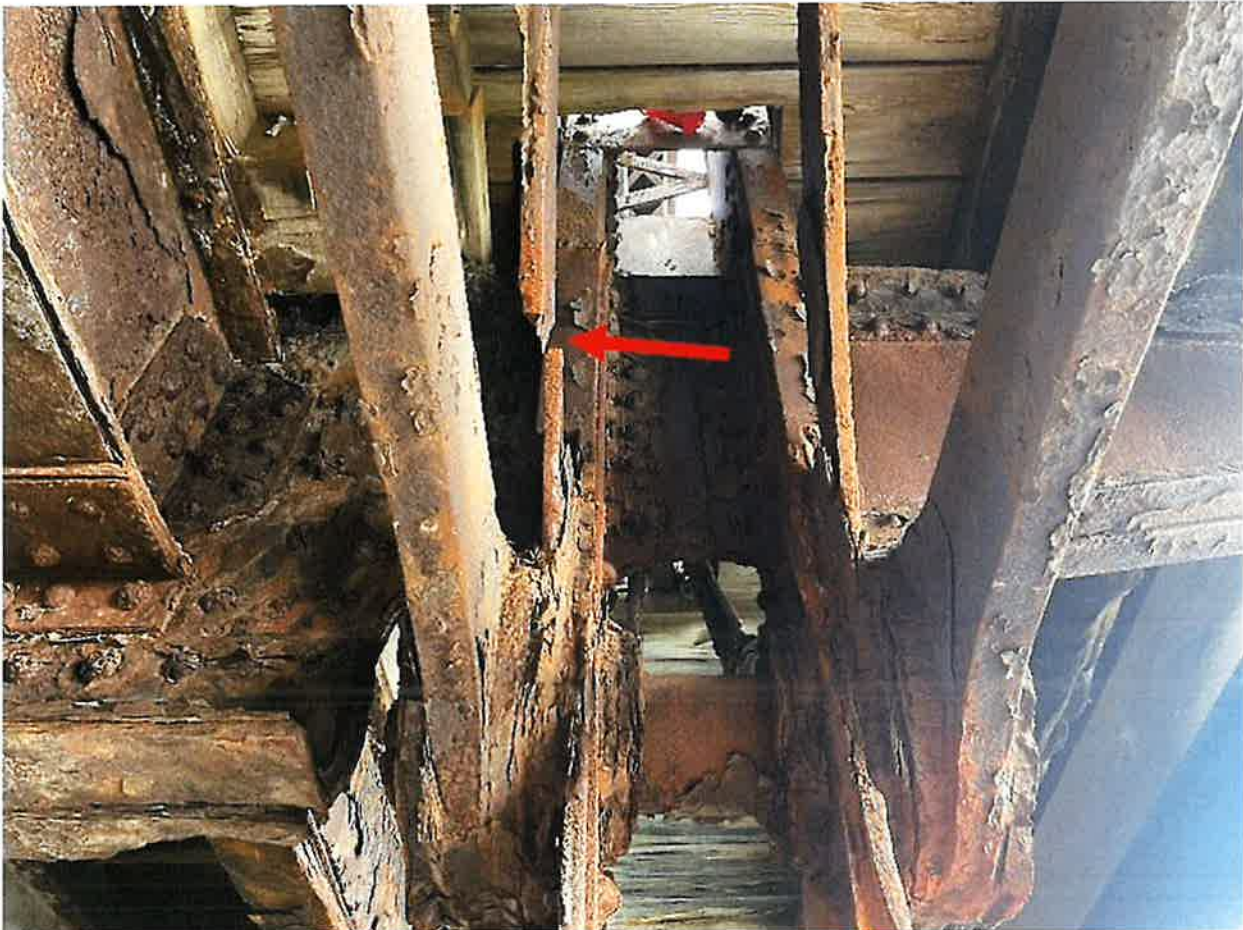
**Photo 6.** Span 2, North Truss, Diagonal, L27-U28 (Looking West)  
The north diagonal has 5/8" remaining average by FW. The south diagonal has completely fractured just above the eyebar connection. The north diagonal has torsional forces applied.

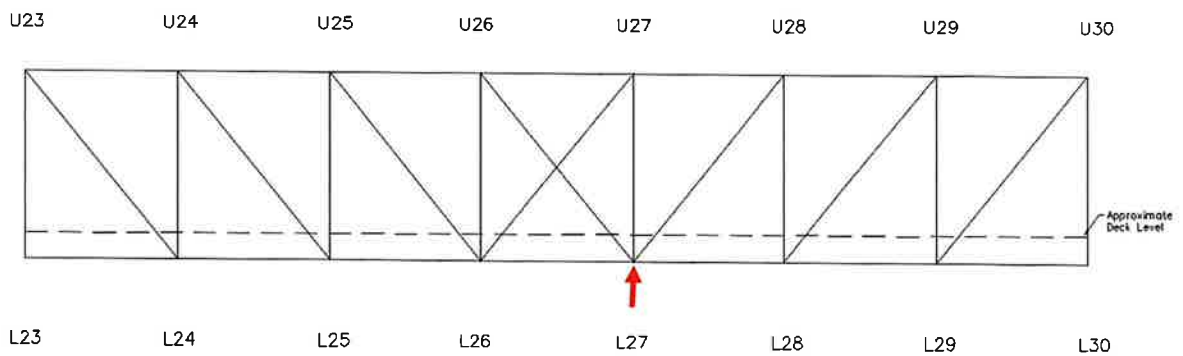
**Span 2, North Truss**  
**South Elevation**  
N.T.S

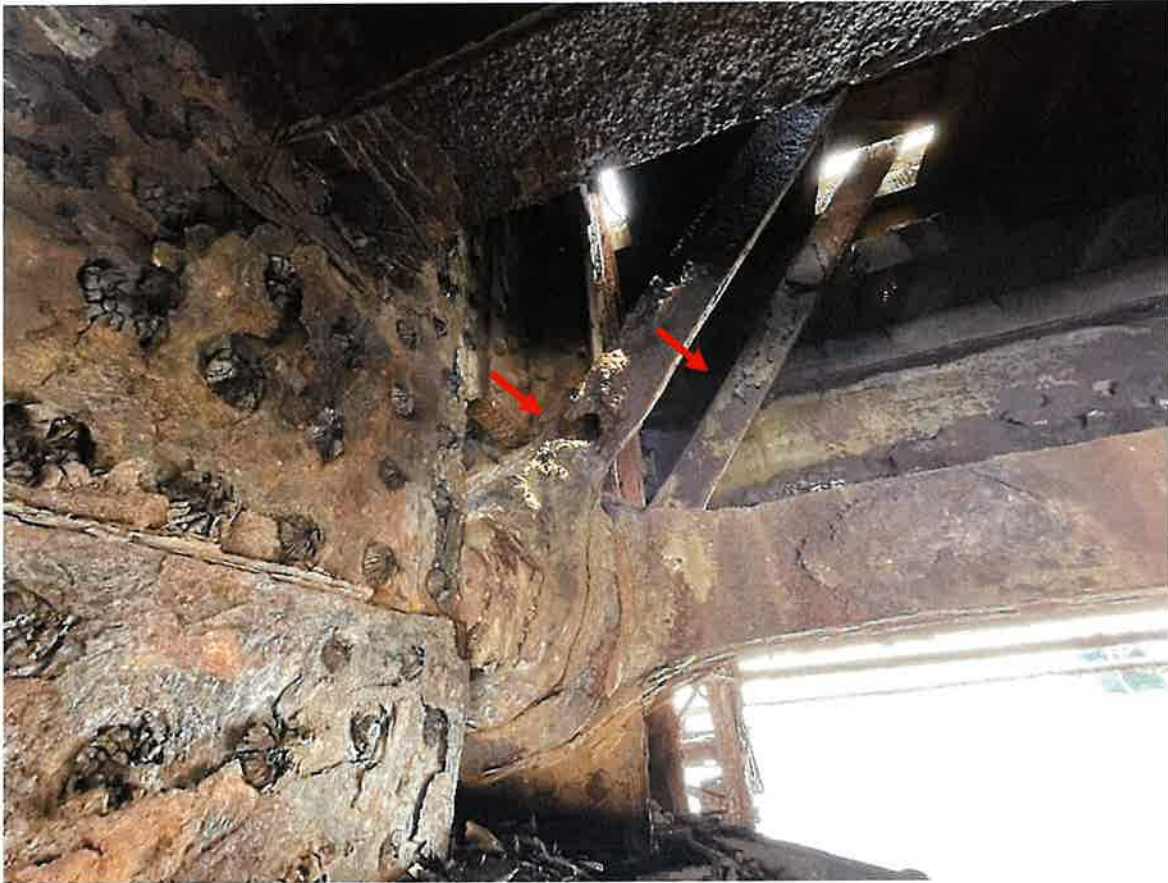
**Photo 7.** Span 2, Center North Truss, Diagonal, L26-U27 (Looking Northwest)  
 The north diagonal bar has between 90% to 75% remaining by FW. The south diagonal bar has two rust holes up to 4" W with less than 50% to knife edge remaining for the remaining width. If the south diagonal bar fails, the north diagonal bar will have torsional forces.

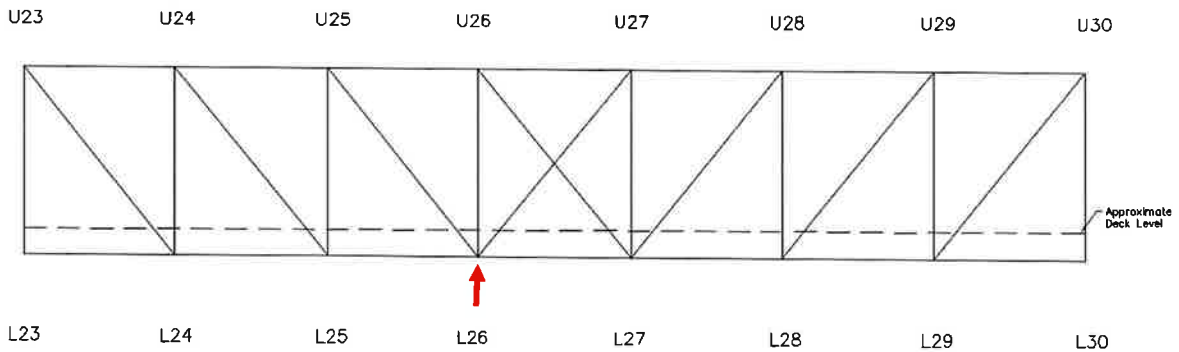
Span 2, Center North Truss  
South Elevation  
 N.T.S

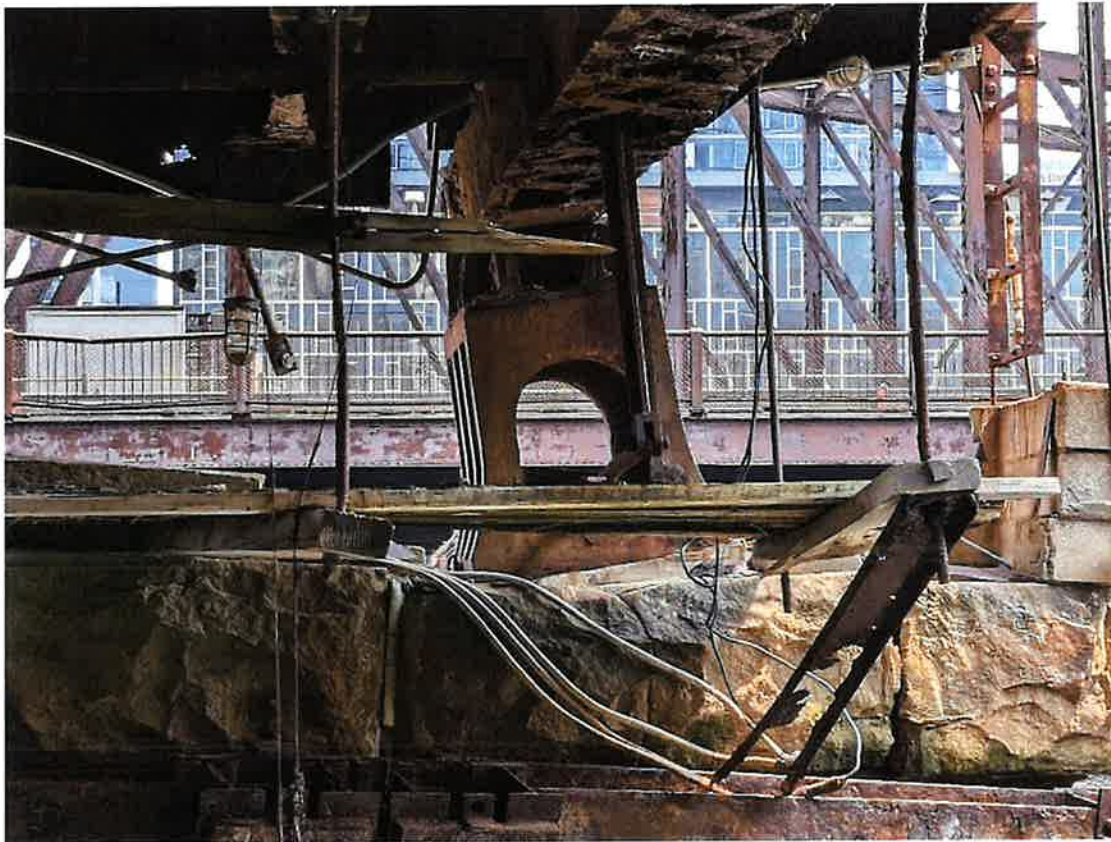
**Photo 8.** Approach Span 1, Pier 1, South Bearing L8 (Looking East)  
Settlement of the pier has caused the rotation of the bearing at A2S.

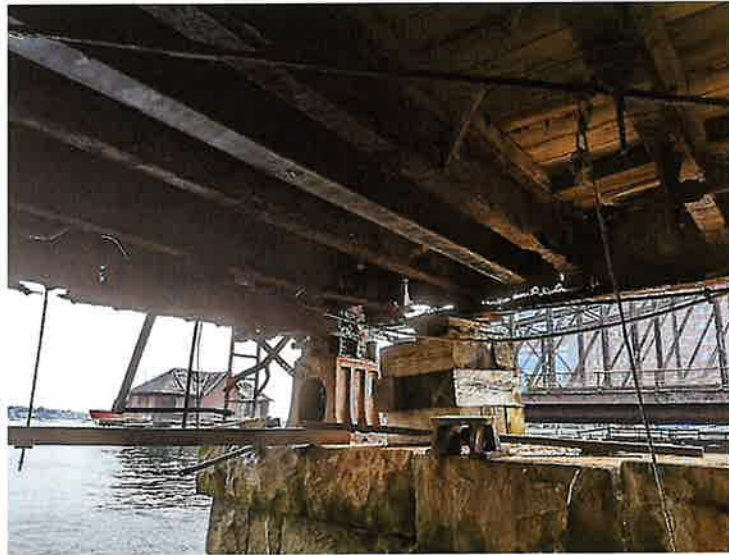
**Photo 9:** Approach Span 1, Pier 1, North Bearing L8 (Looking Northeast)  
The pier bearings typically have adjacent timber cribbing.

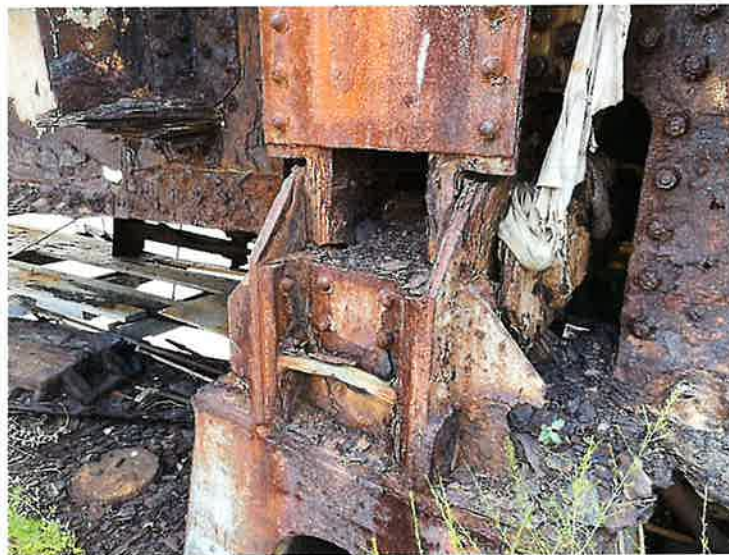
**Photo 10:** Approach Span 2, Pier 2, Center North Bearing L23 (Looking East)  
The pier bearings typically advanced deterioration with rust holes and pack rust.

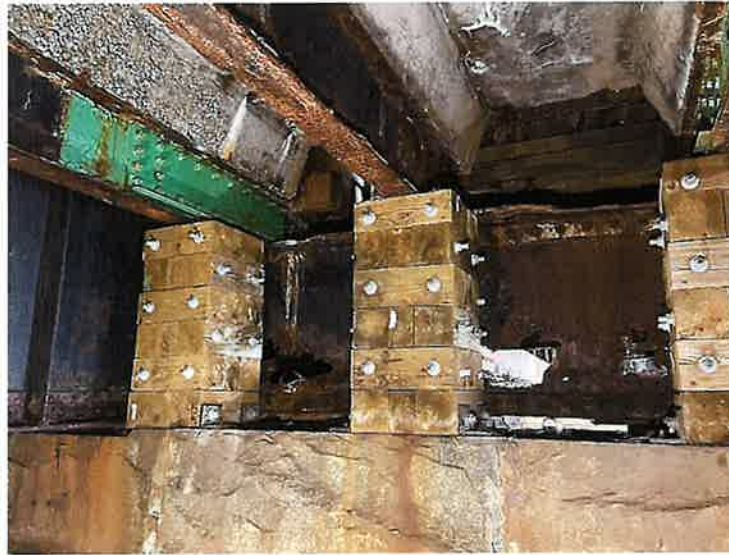
**Photo 11:** Approach Span 3, Pier 3, Timber Cribbing Bearings (Looking West)  
Approach Span 3 stringers and deck bear directly on the timber cribbing due to the failed pier floorbeam.

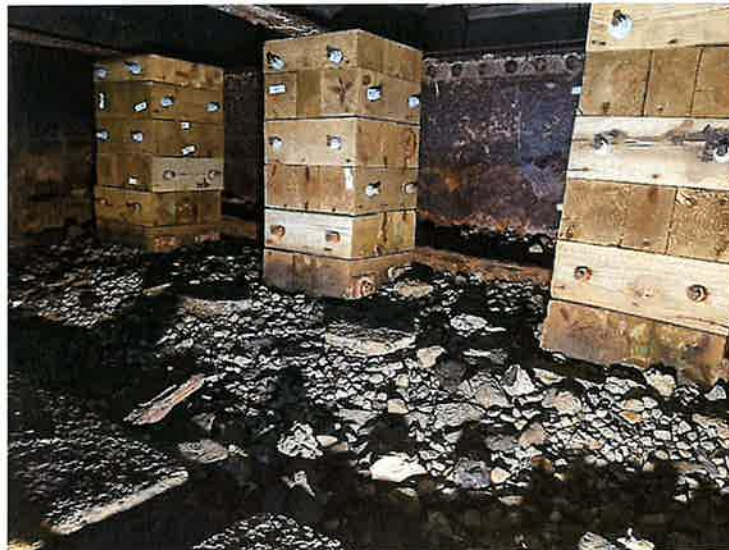
**Photo 12:** Approach Span 3, East Abutment, Timber Cribbing Bearings (Looking East)  
Approach Span 3 stringers and deck bear directly on the timber cribbing due to the failed abutment floorbeam.

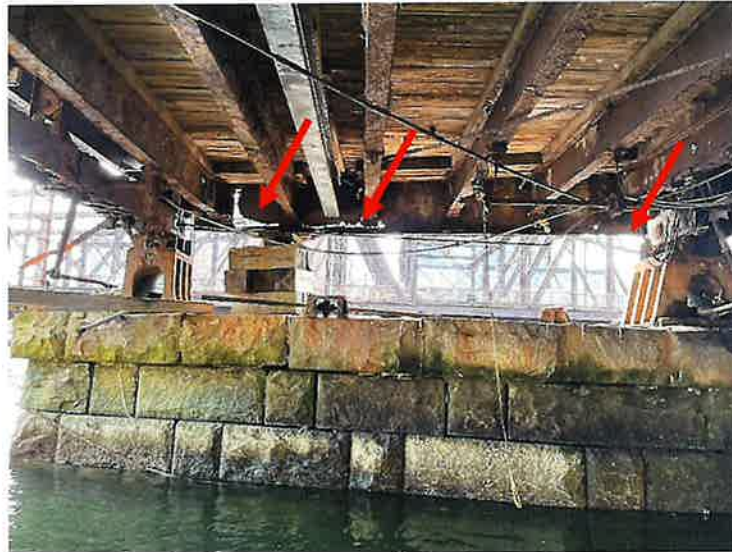
**Photo 13:** Approach Span 1, Pier 1, Floorbeam FB8 (Looking East)

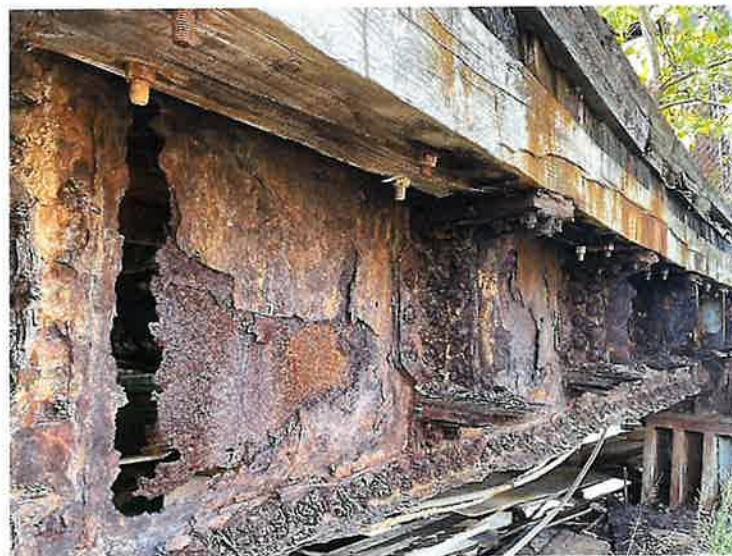
**Photo 14:** Approach Span 2, Pier 2, Floorbeam FB23 (Looking East)

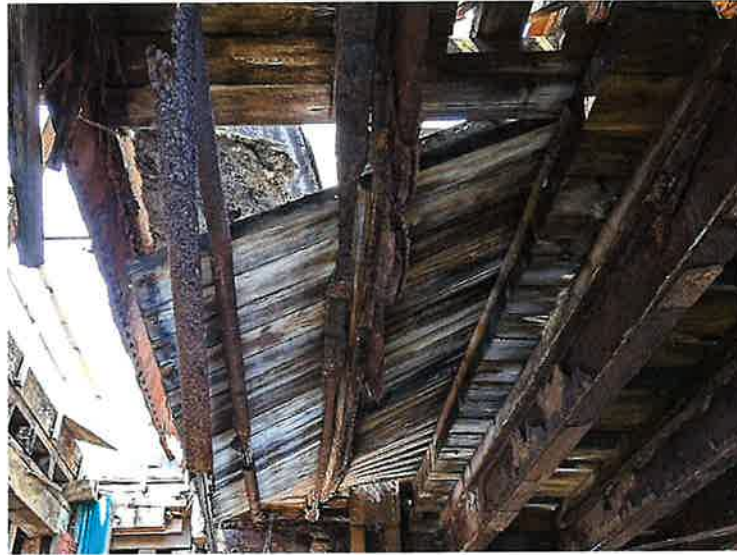
**Photo 15:** Approach Span 1, South Bay, Between Floorbeams FB1 and FB2, Deck and Sidewalk Stringers (Looking West)

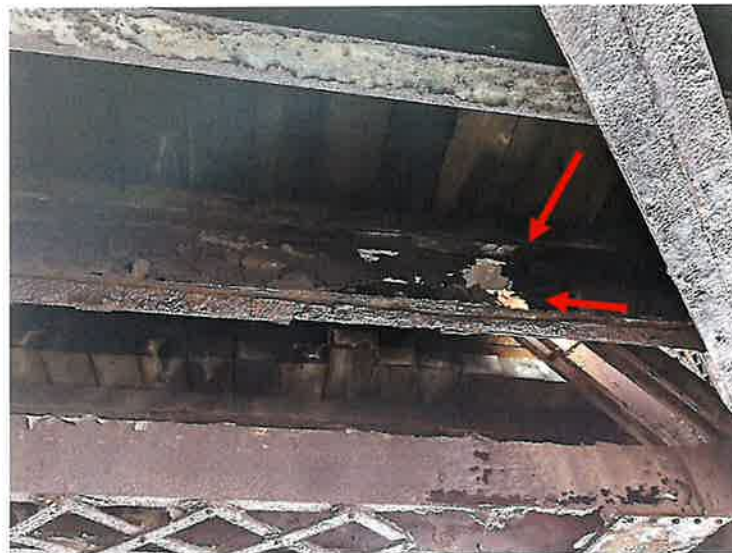
**Photo 16:** Approach Span 1, Center Bay, Between Floorbeams FB2 and FB3, Stringer 6 (Looking North)

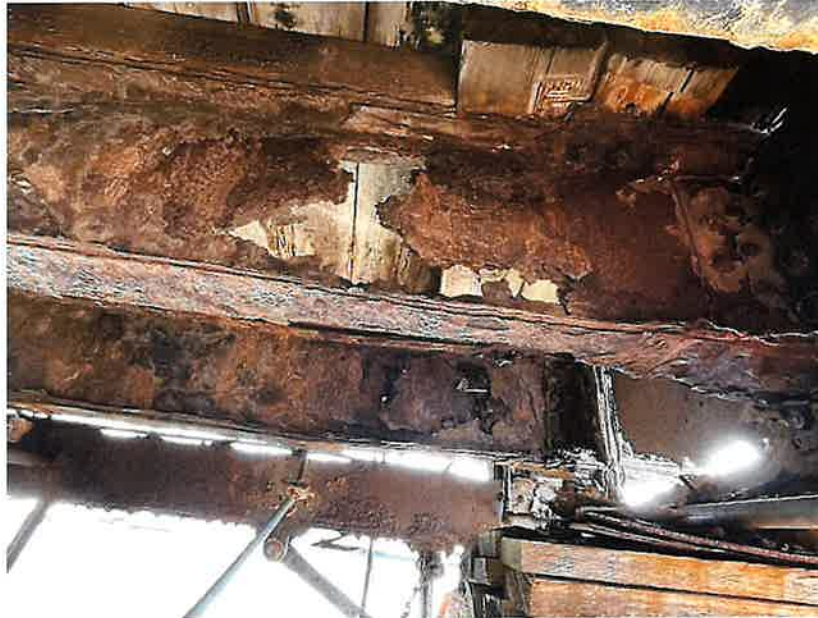
**Photo 17:** Approach Span 1, North Bay, Between Floorbeams FB7 and FB8, Stringer 5 (Looking East)

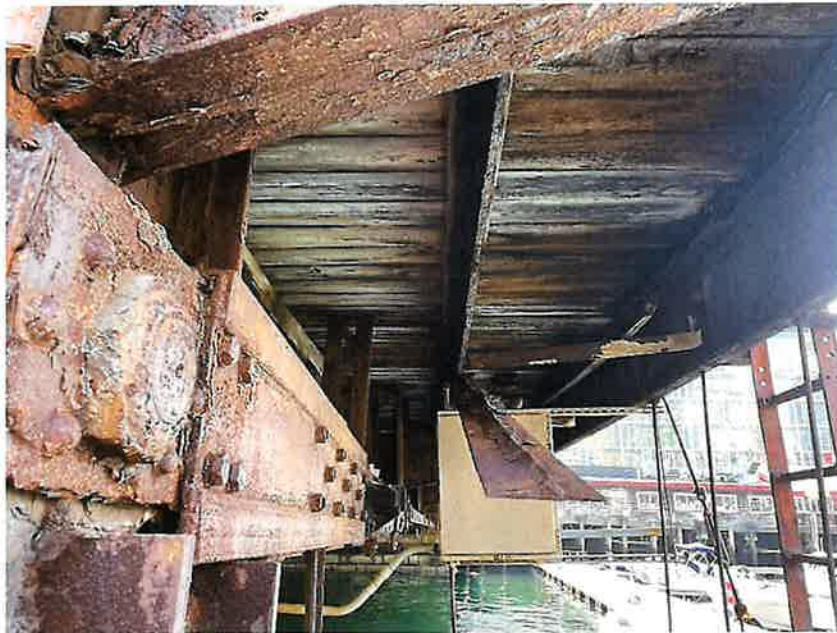
**Photo 18:** Approach Span 2, South Bay, Between Floorbeams FB23 and FB24, Stringer 2 (Looking East)
