November 4, 2024

Ms. Brona Simon  
State Historic Preservation Officer  
Massachusetts Historical Commission  
220 Morrissey Boulevard  
Boston, MA 02125  
(via certified mail)

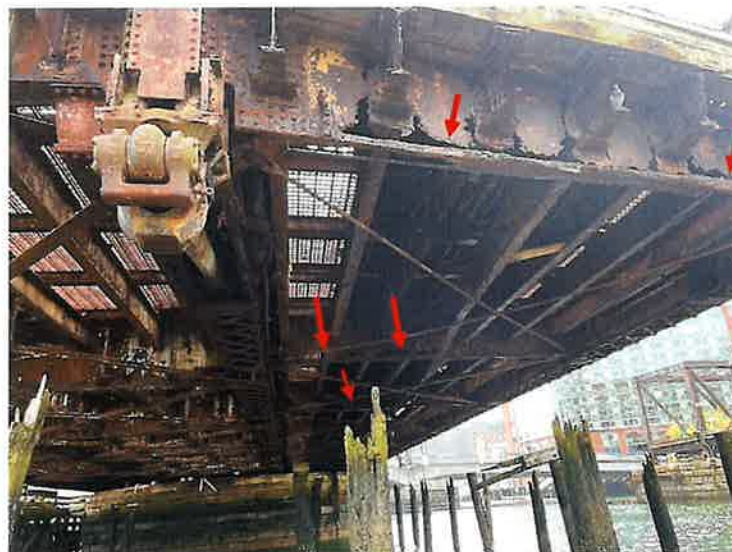
**Photo 20:** Swing Span, North Bay, Between Floorbeams FB21 and FB22 (Looking True South)  
Swing Span floorbeams typically have large web rust holes with paper-thin remaining for the remaining web.

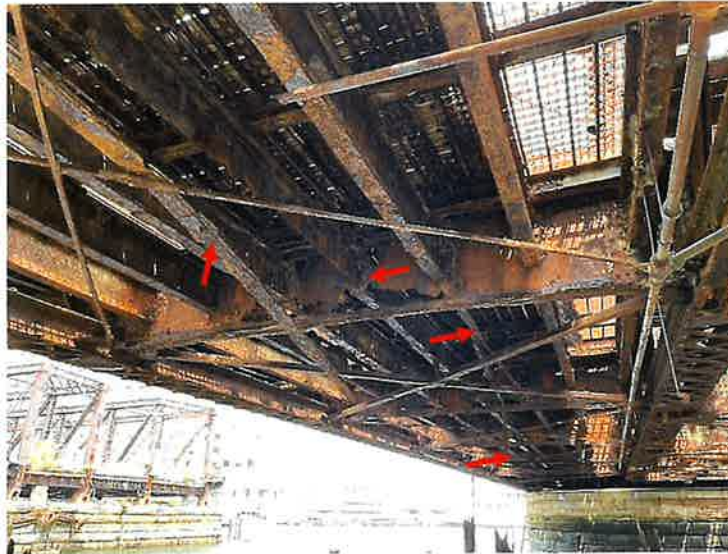
**Photo 21:** Swing Span, North Bay, Between Floorbeams FB10 and FB11 (Looking True North)  
Swing Span stringers typically have large rust holes however, these two stringers have failed webs and flanges, with hanging sections from the superstructure.

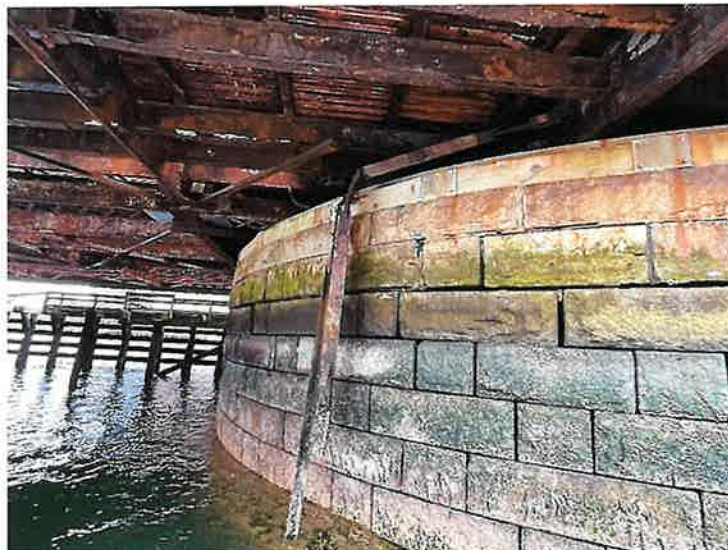
**Photo 22:** Swing Span, Center Bay, Between Floorbeams FB16 and FB17, Floor System Bracing (Looking True South)

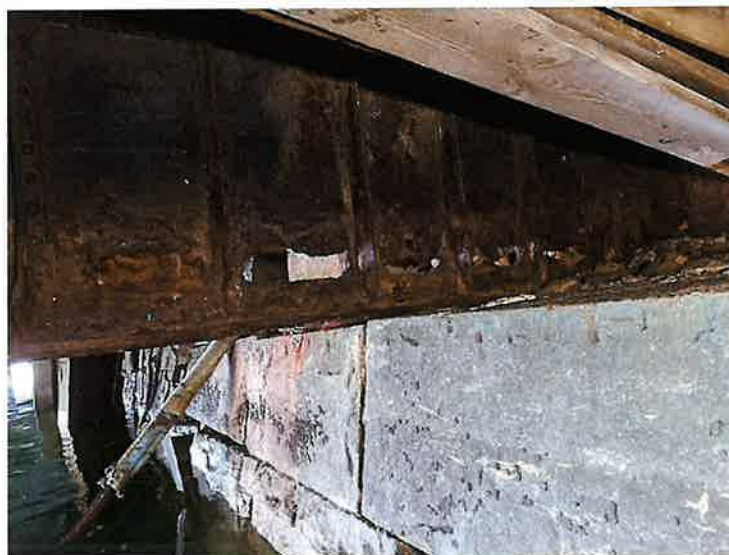
**Photo 23:** Approach Span 3. Girder P, Between Floorbeams FB5 and FB6 (Looking North)  
The approach fixed span girders typically have rust holes at the bottom of the webs and severely deteriorated bottom flanges.

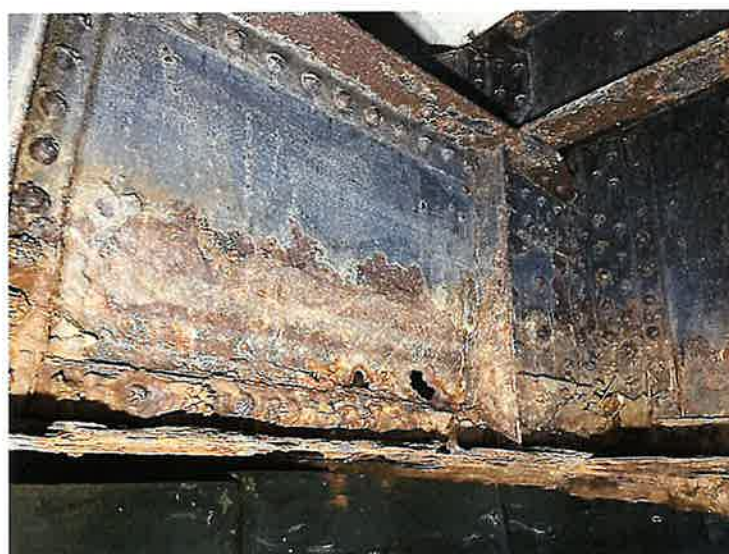
**Photo 24:** Approach Span 3. Floorbeam FB5, Between Girders GO and GP (Looking East)  
The approach fixed span interior floorbeams typically have small rust holes and section loss along the bottom of the web

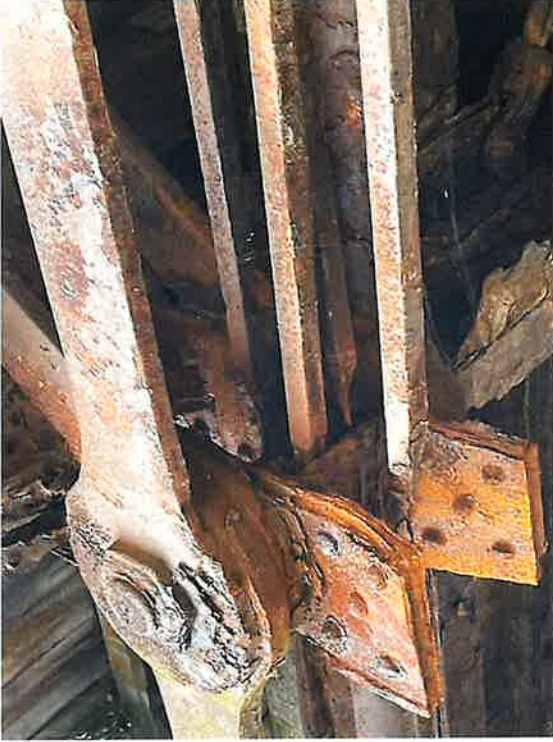
North Truss at L2-L3 (2024)  
\*Continuous deterioration of remaining U-Bar will cause failure of lower Chord L2-L3

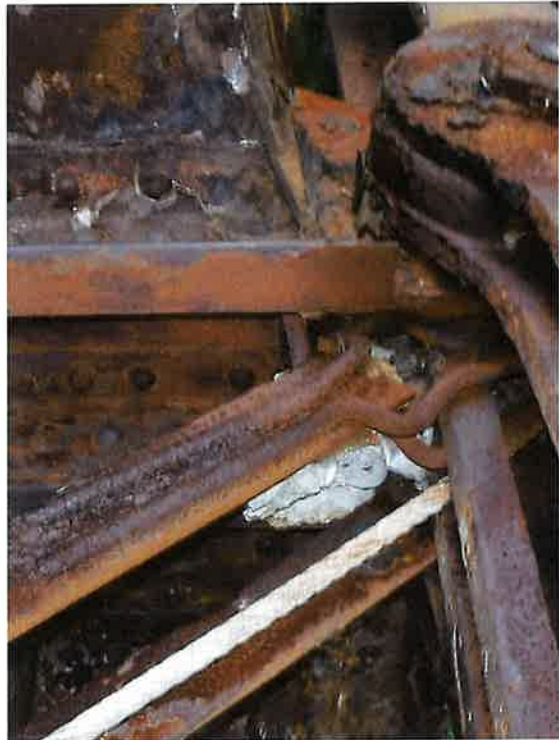
North Truss- L4U5 at L4 (2017)

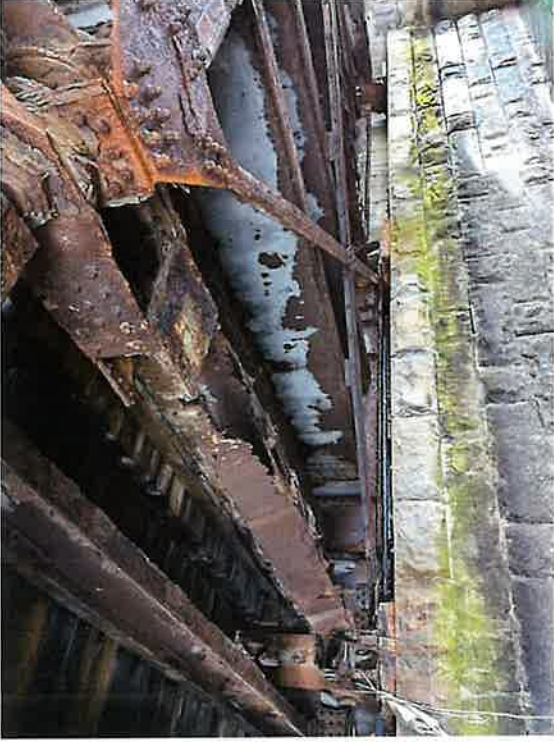
Center South Truss at L1-L2 (2024)  
\*Continuous deterioration of end strut will cause a falling hazard. This end strut is not part of the load path.

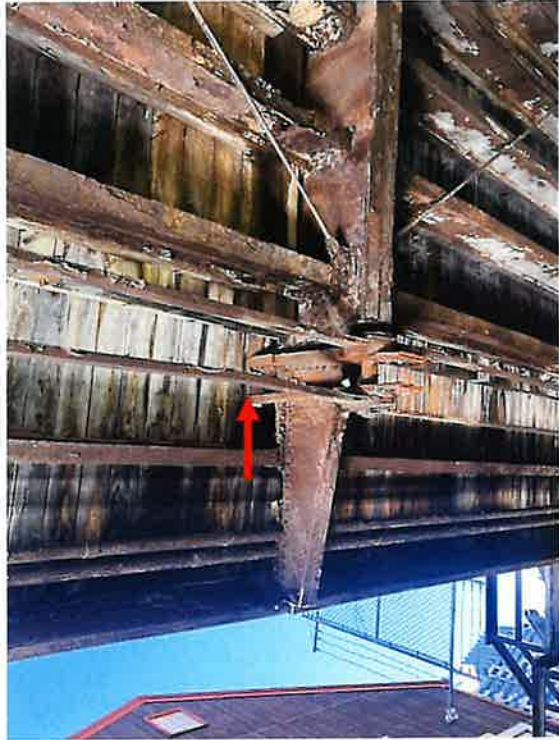
South Truss at L3-L4 (2022)

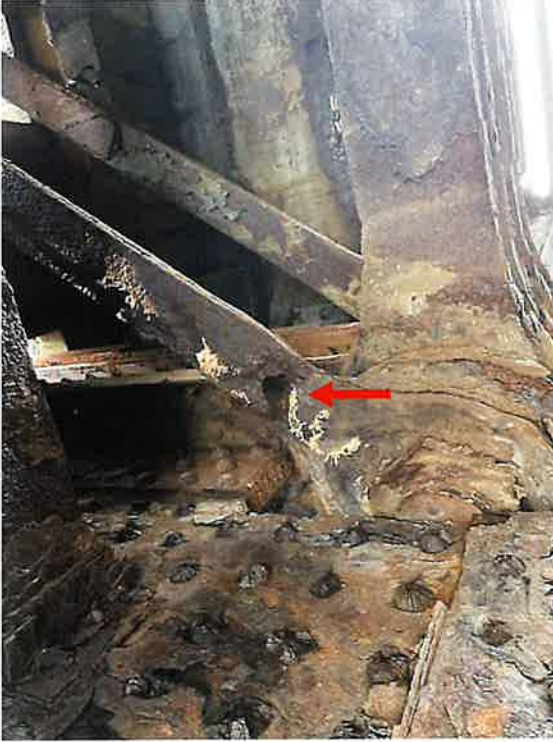
Center North Truss at L26U27 at L26 (2024)  
\*Continuous deterioration of diagonal member will lead to failed/fractured member

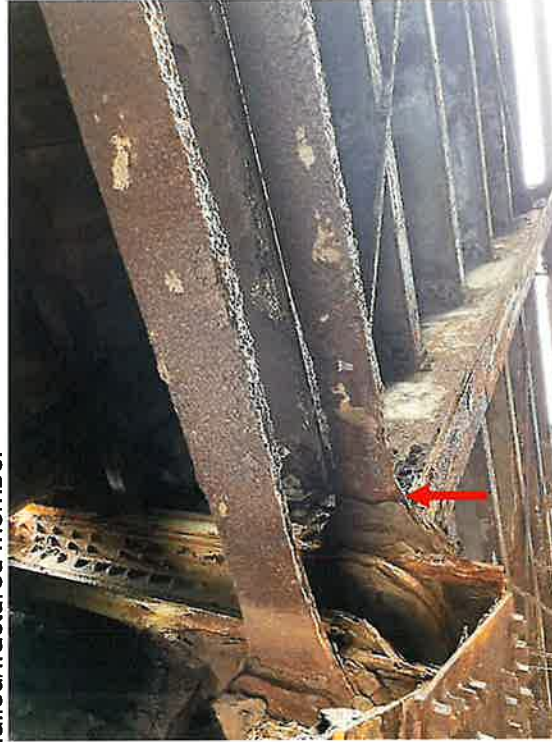
Center North Truss at L24L25 at L24 (2024)

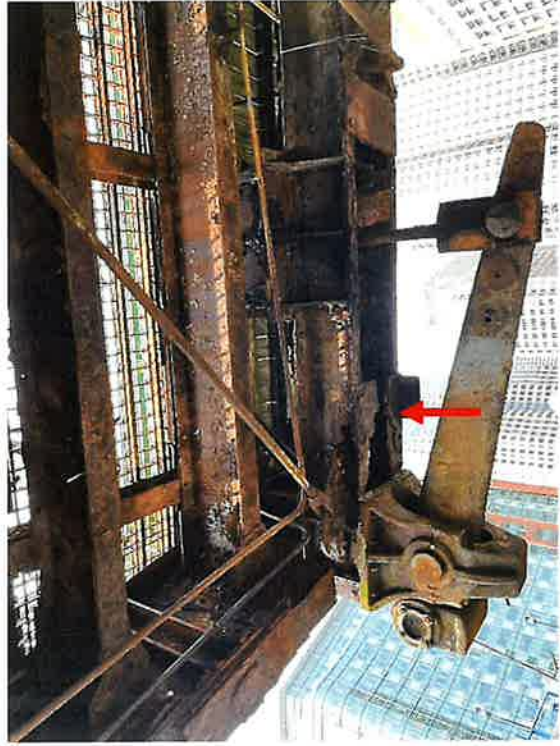
North Truss at L9L10 at L9 (2024)  
\*Advanced deterioration of existing rust hole since the 2017 inspection.

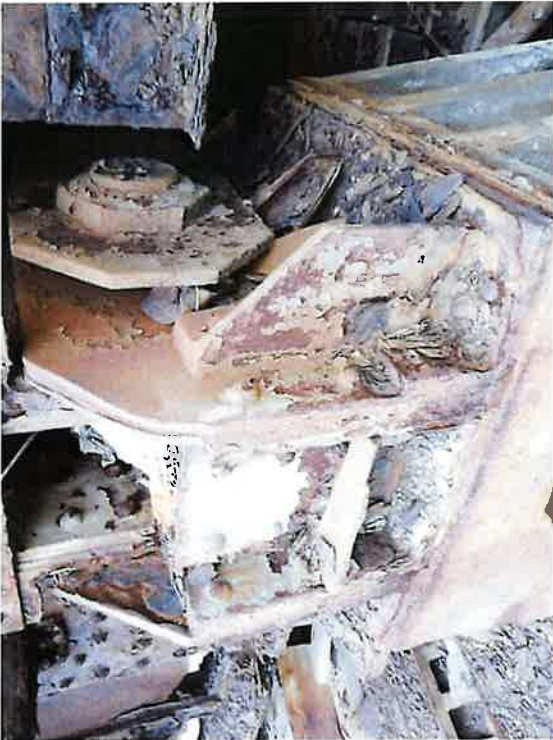
Pier 2, Center South Truss L23 Bearing (2017)

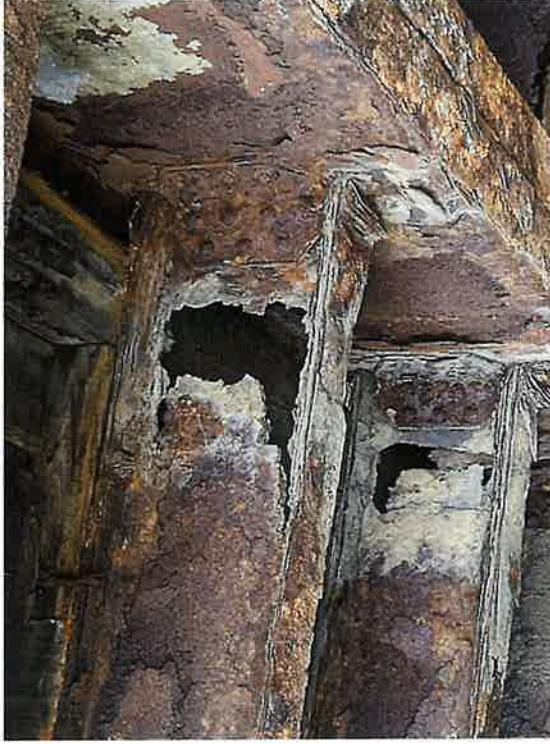
North Bay, Btw FB2 & FB3 – Stringer S4 (2024)  
\*Progressive deterioration of existing rust hole since the 2017 inspection.

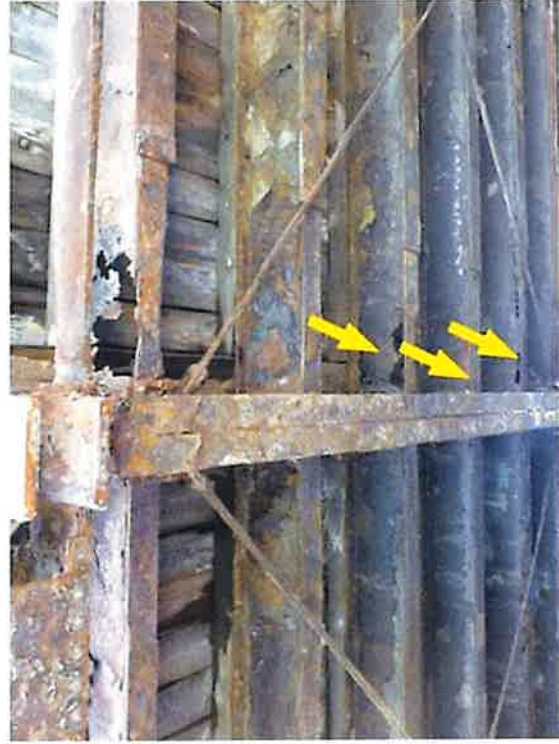
North Bay, Btw FB6 & FB7 - Stringers S2 to S6 (2017)

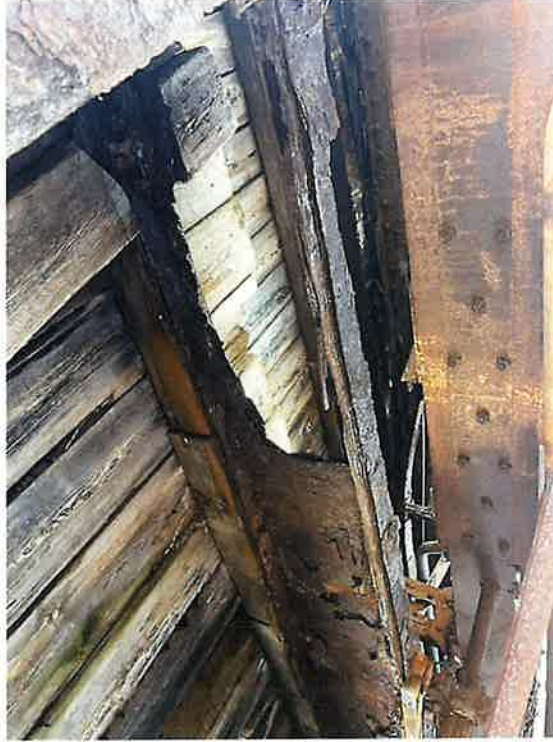
South Bay, Btw FB23 & FB24 – Stringer S1 (2024)  
\*Advanced deterioration of existing rust hole since the 2017 inspection.

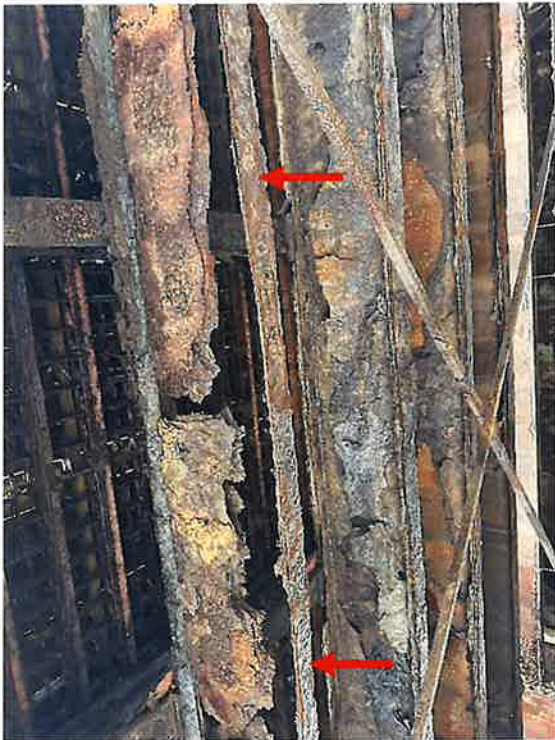
Swing Span, North Bay, Btw FB10 & FB11 –  
Stringer S2 (2022)

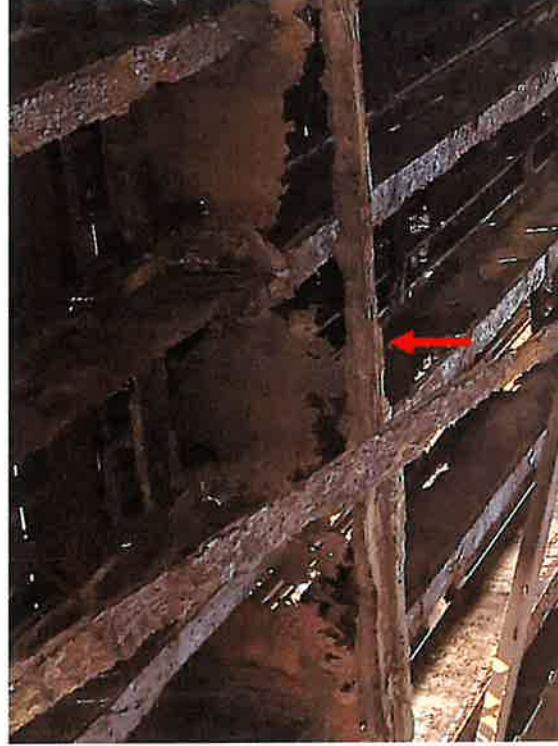
Swing Span, North Bay - Floorbeam FB10 (2024)  
\*Advanced deterioration of existing rust hole since the 2017 inspection.

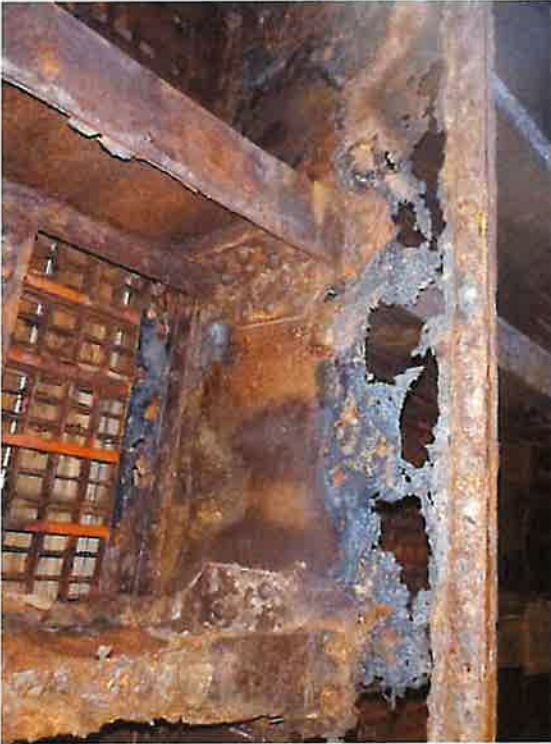
Swing Span , North Bay - Floorbeam FB17 (2017)

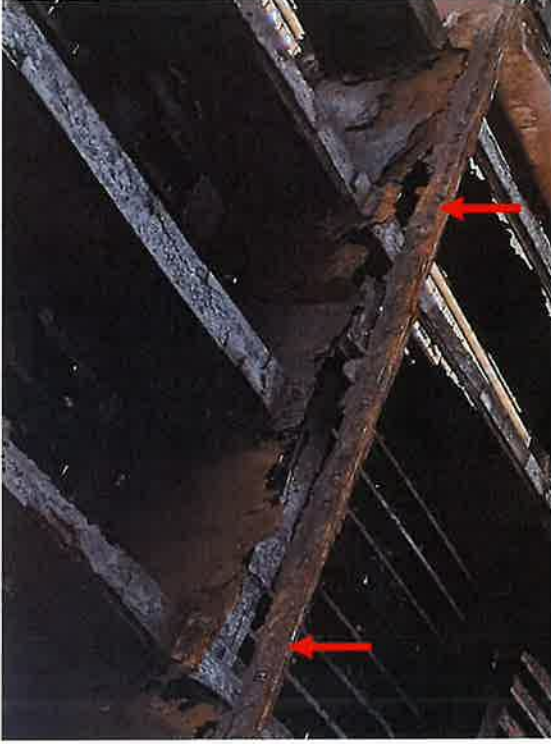
Swing Span , North Bay - Floorbeam FB17 (2024)  
\*Advanced deterioration of existing rust hole since the 2017 inspection.

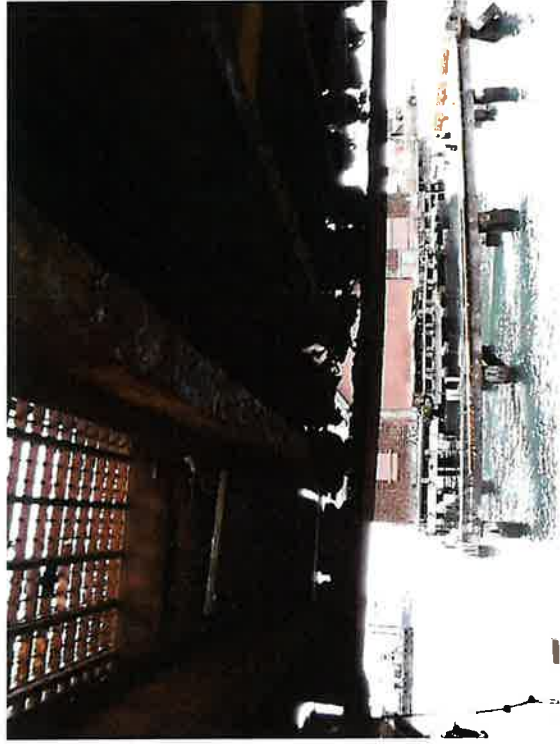
Swing Span , North Bay - Floorbeam FB22 (2017)

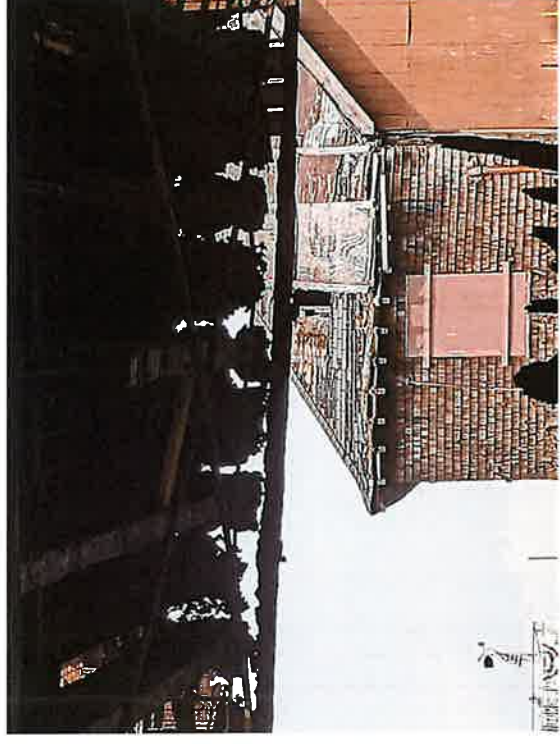
Swing Span , North Bay - Floorbeam FB22 (2024)  
\*Advanced deterioration of existing rust hole since the 2017 inspection.
