### FPNA NEIGHBORHOOD GATHERING: REDUCING FLOOD RISK, NEIGHBORHOOD UPDATES & YOUR TOP WISHES

### REDUCING THE RISK OF STORM WATER BACK SURGE FLOODING

### Fort Point Channel – South Boston Tributary Areas

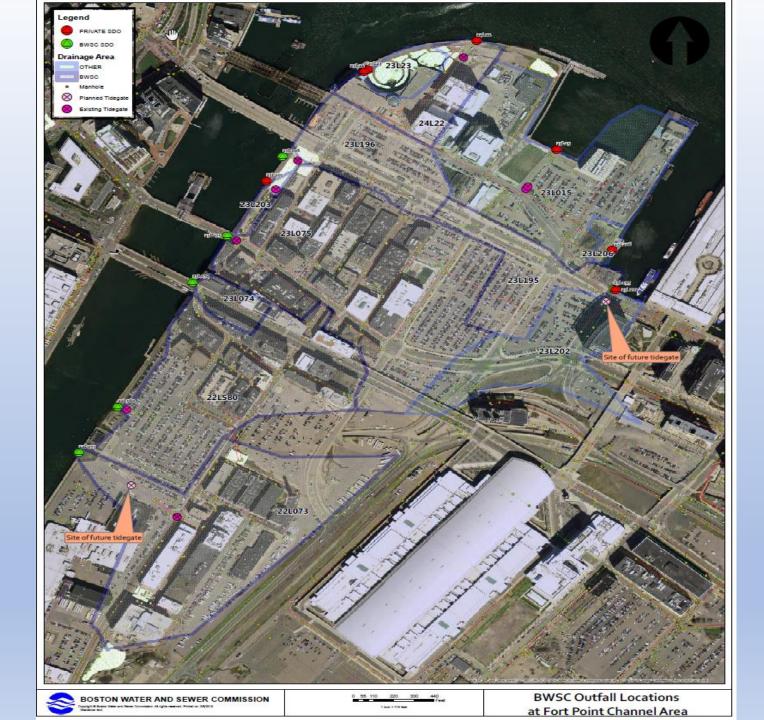
Blue lines mark tributary boundary lines.

All water that falls within these polygons outlets to the designated outfall

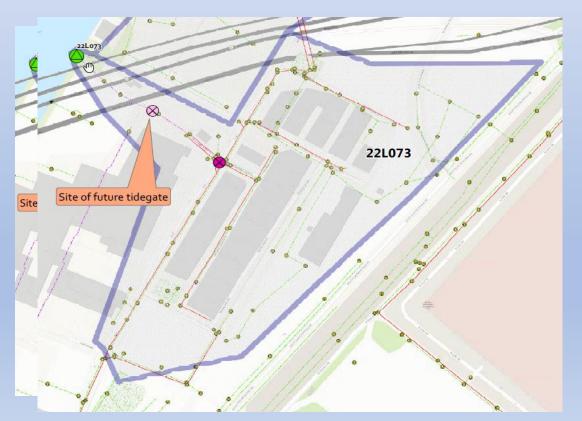
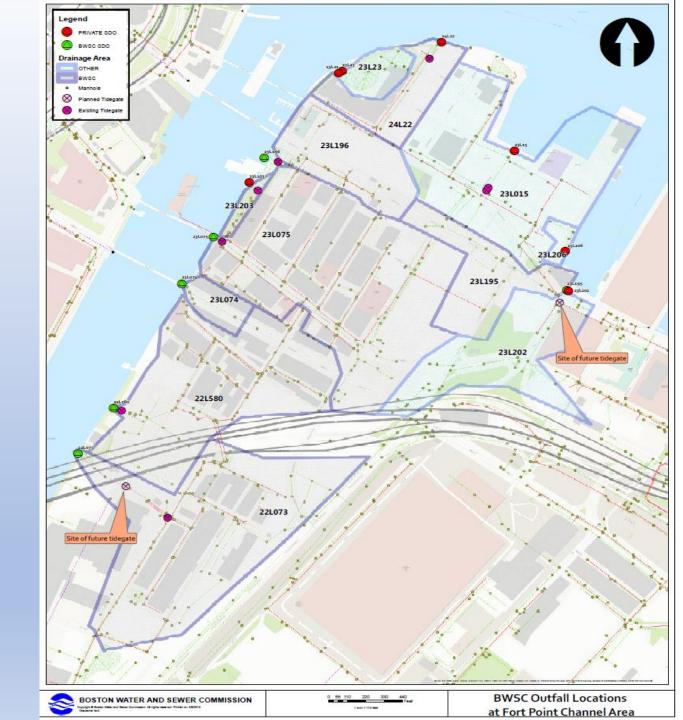
Blue Lines indicate area which flows to individual outfall

Sub area shown below:

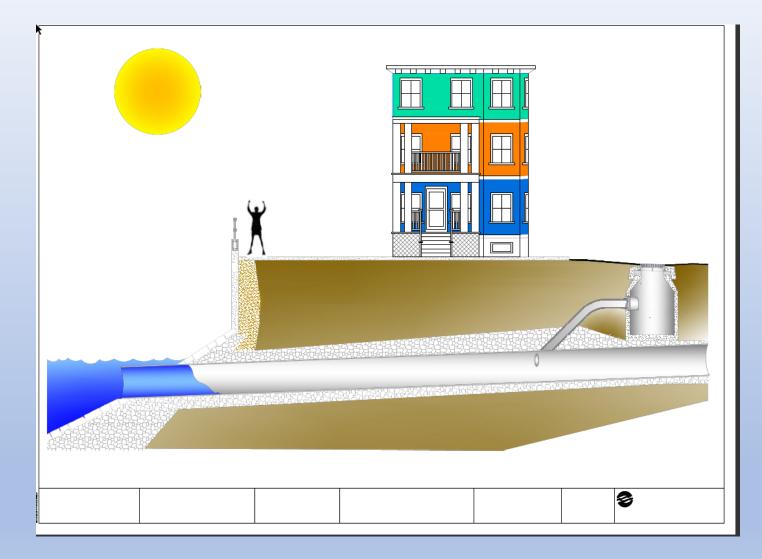
### Sunny Day – no worries

Unless there is an extreme high tide predicted, there are no major concerns for unprotected outfalls

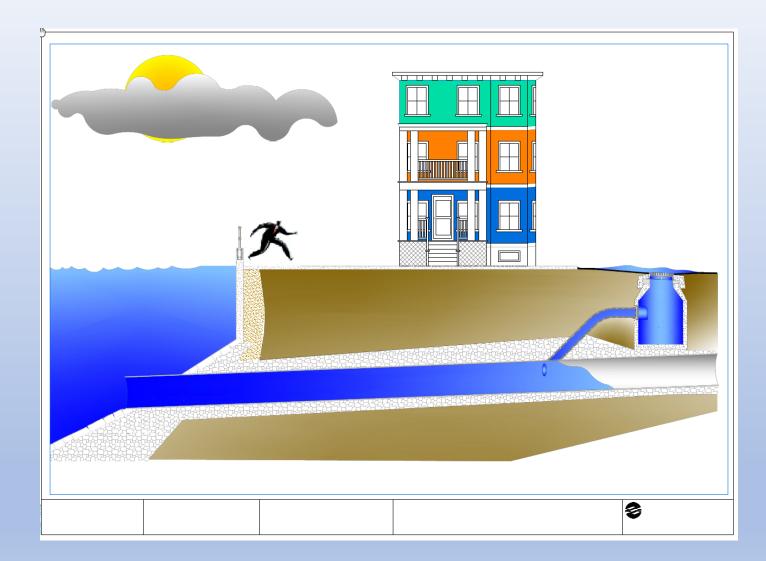
### Wet Weather Event

During high tides and extreme rainfall, or extreme high tides with no rainfall, unprotected drain lines allow for major surcharging of the systems putting streets and all basement areas of buildings under stress

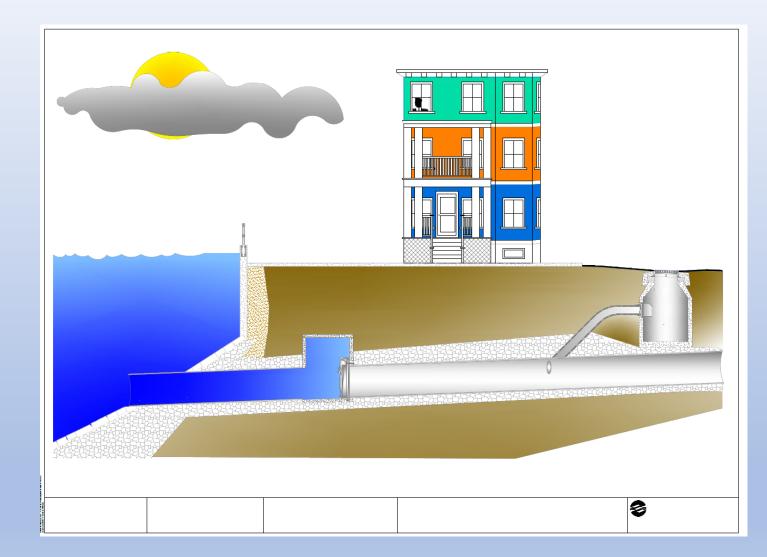
### Tidegates Protect Drain Systems

During Extreme High tides, tide gates can keep the tide from flowing up the drainage system, protecting roadways and buildings.

When there are extreme tides and there is rainfall, the tidegates allow for storage capacity until the tide recedes. (Storage may be limited)

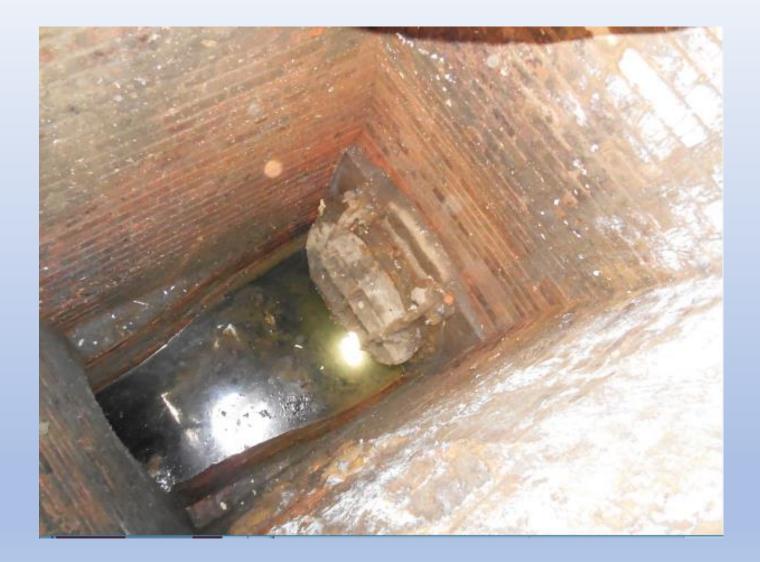
# Double tidegate within chamber

Cast Iron Tidegate in Deep Chamber

Special entry precautions must be used when entering this chamber to perform maintenance

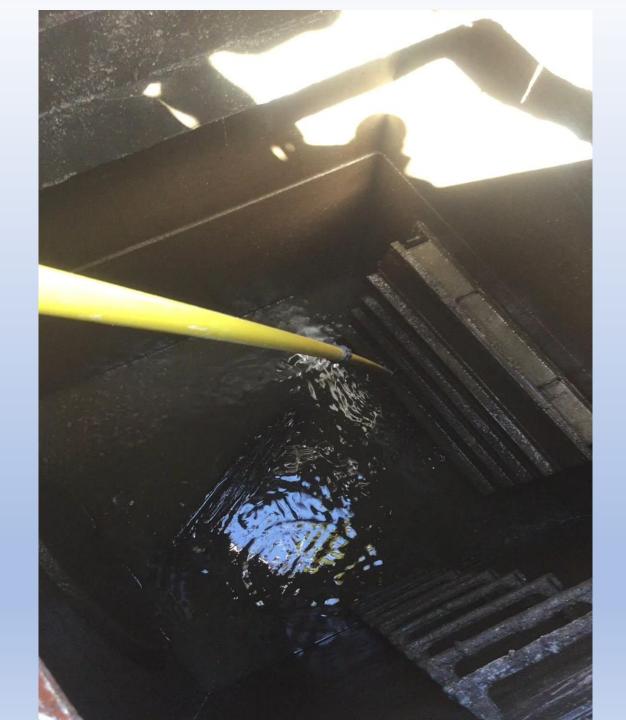
Exercising a large flexible tidegate at Martin Richard Park

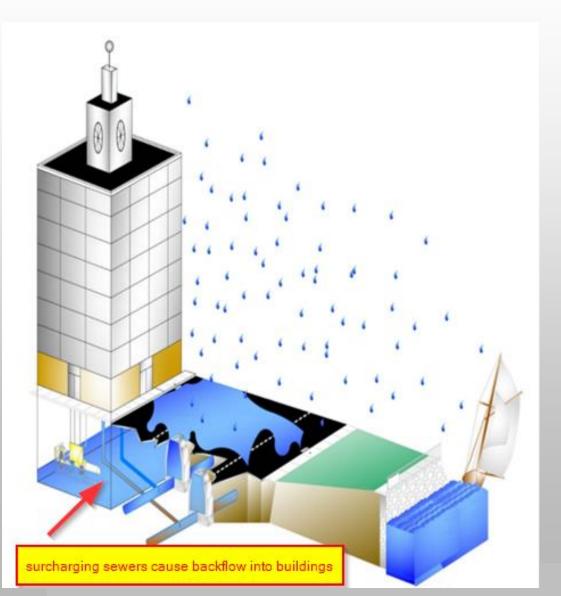
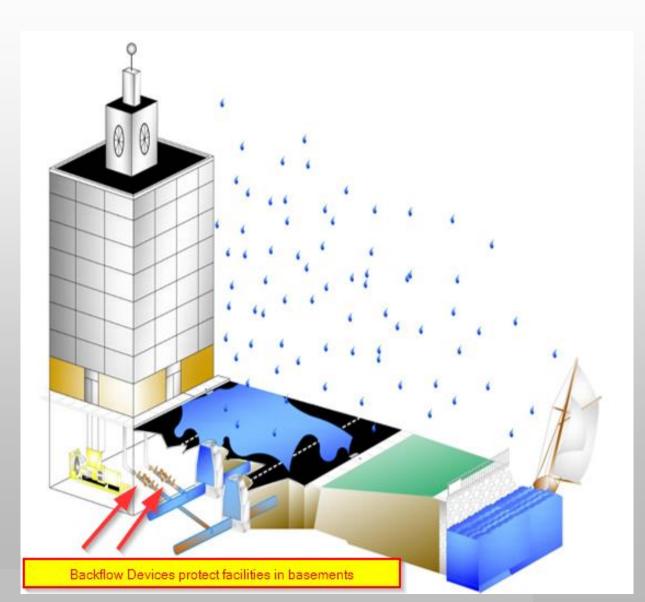
### **Private Property Issue:** Internal basement flooding from unprotected facilities connected to sewers and drains

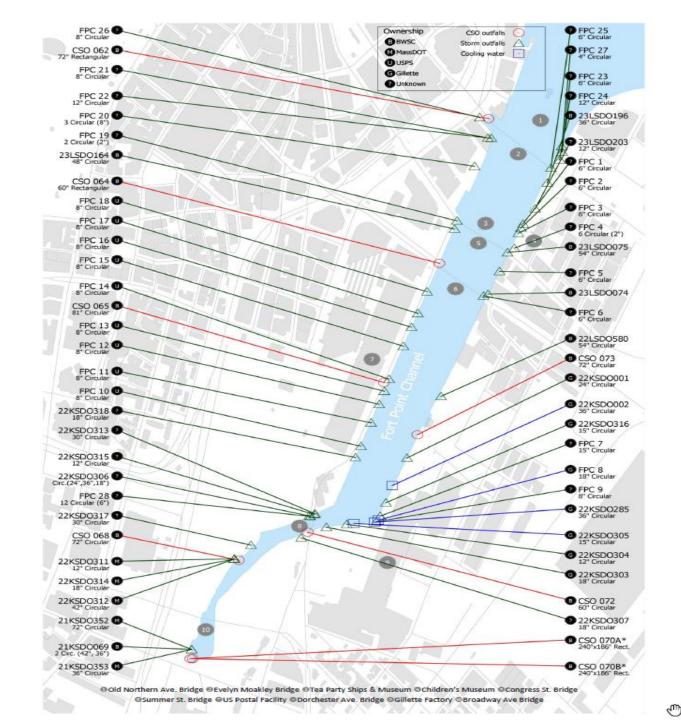
### Fort Point Channel Outfalls

Reported outfalls observed during a 2014 study of the water quality in the Fort Point Channel

(BWSC (14), MassDOT(13), Gillette(10), USPS (9), Other Private(3), Require Further investigation (15) as of 5/22/18)

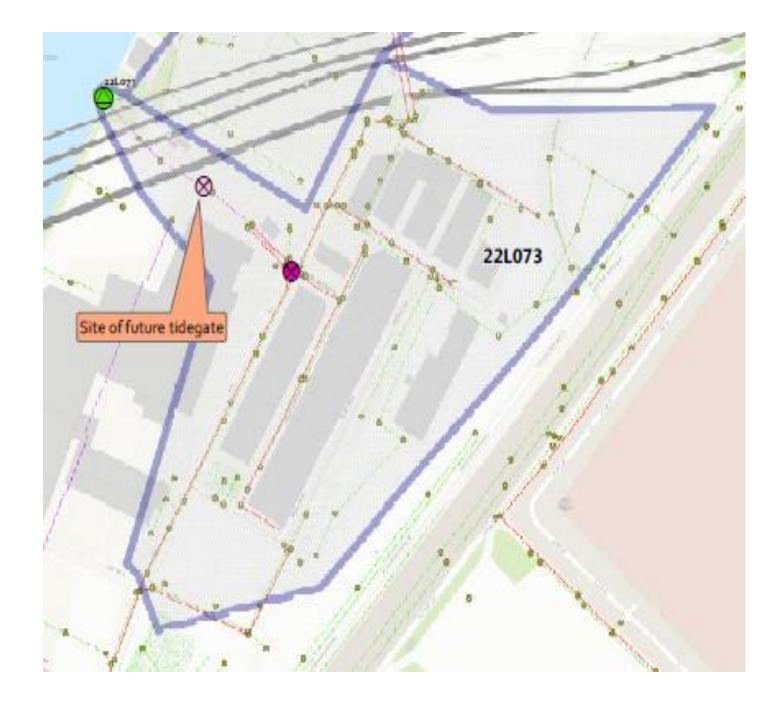
### Mt Washington Ave. Tidegate

Construction Ongoing to install new tidegate to protect tributary area to Outfall 22L073

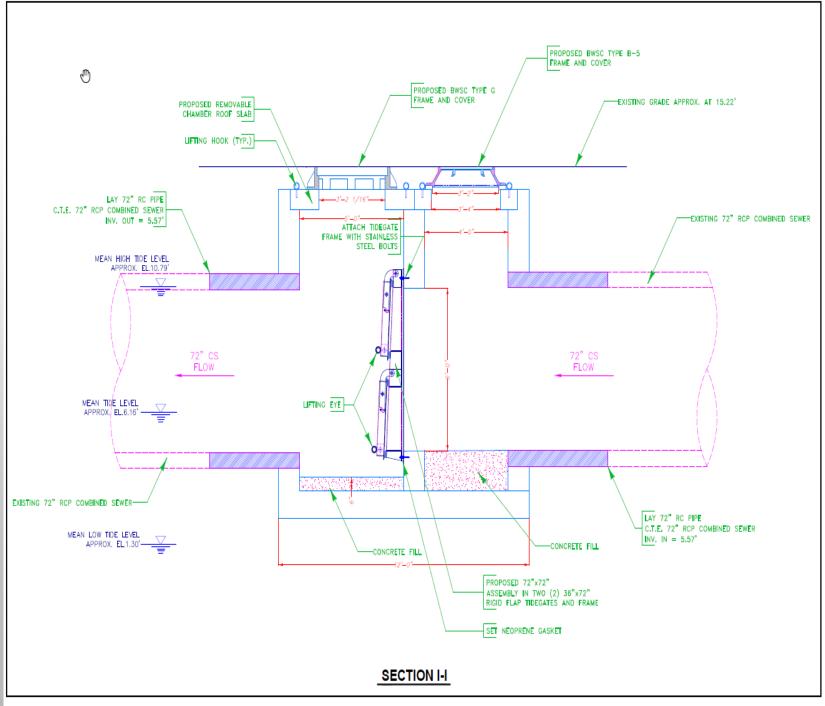
### Mt WashingtonAve Tidegate Drawing

Cross-sectional view of new tidegate and chamber
